# The Aisled Barn, Wycoller, Lancashire

## Archaeological Survey and Historical Analysis of the Building

September, 2000

Lancashire County Council

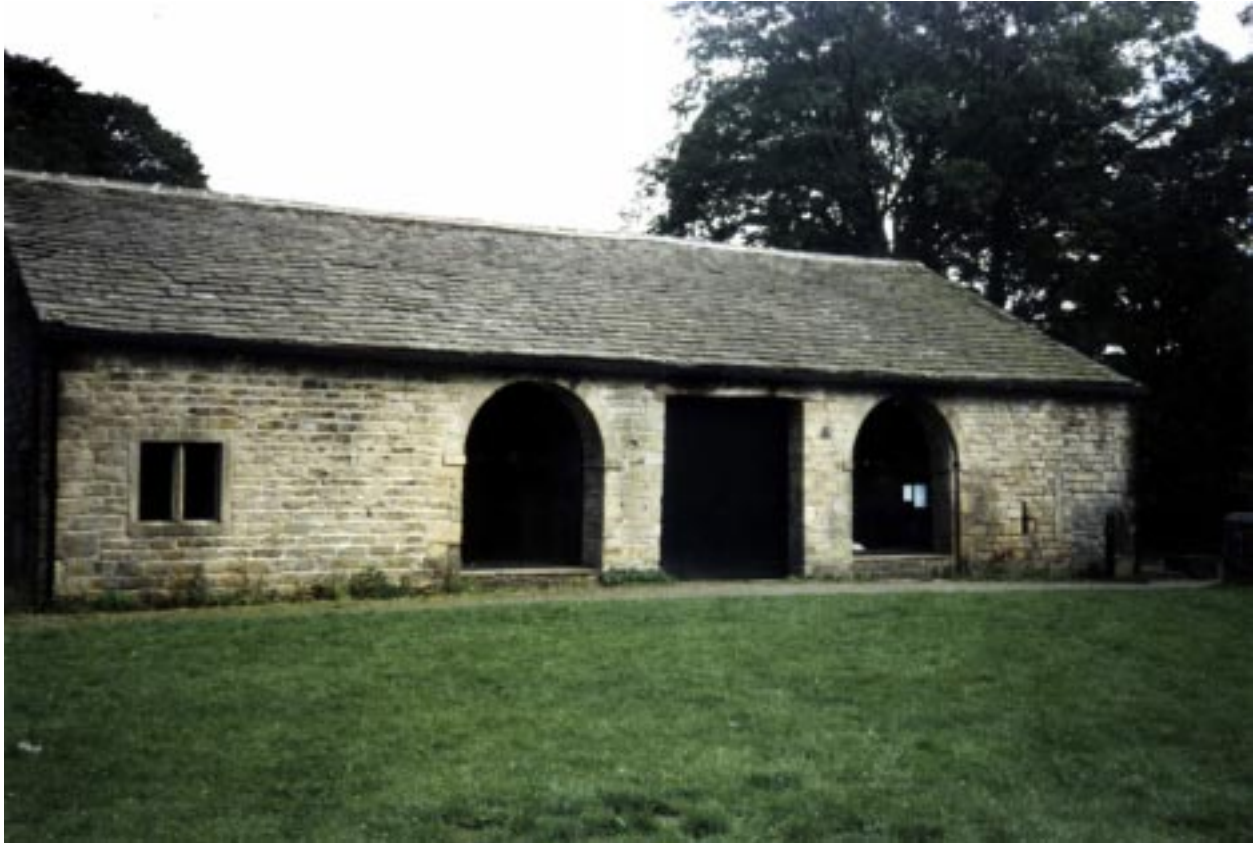
1. Symmetrical west facade created in the 18th century

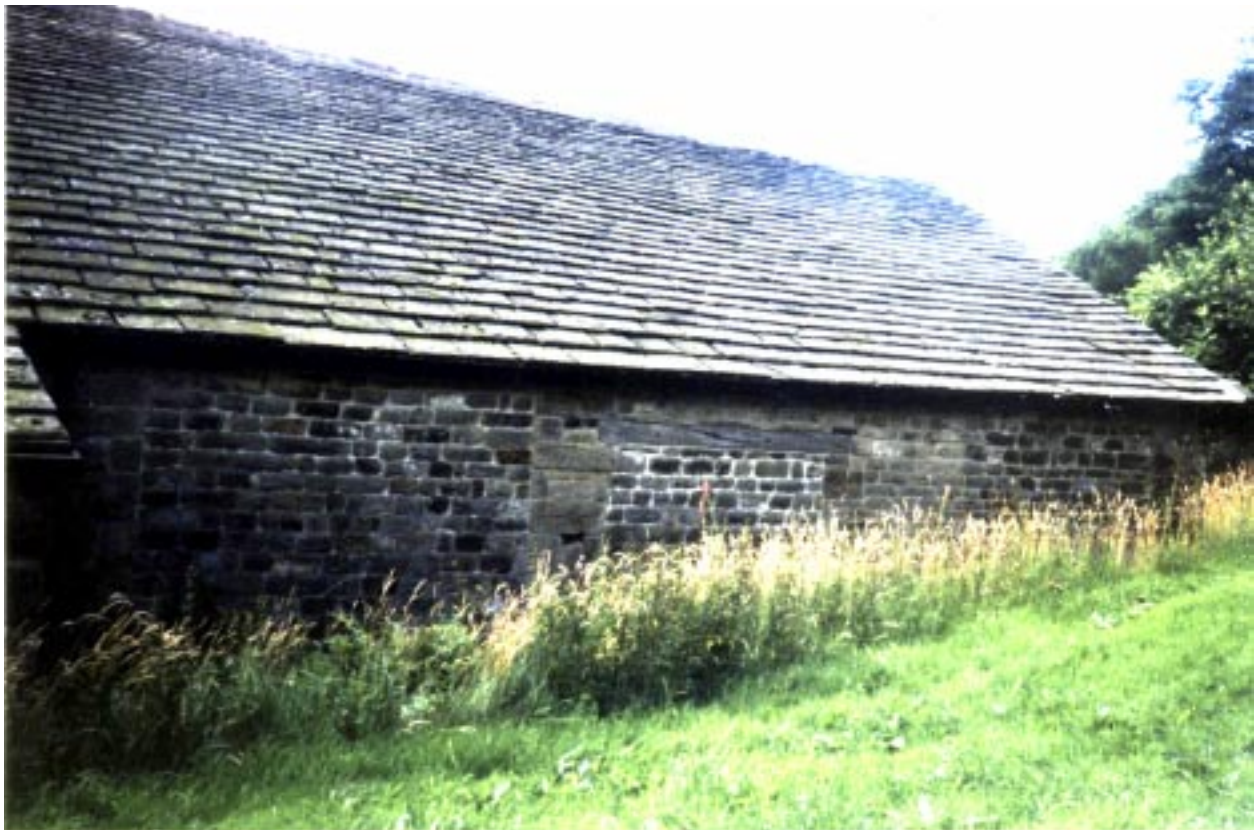
2. Barn and outshot from the East

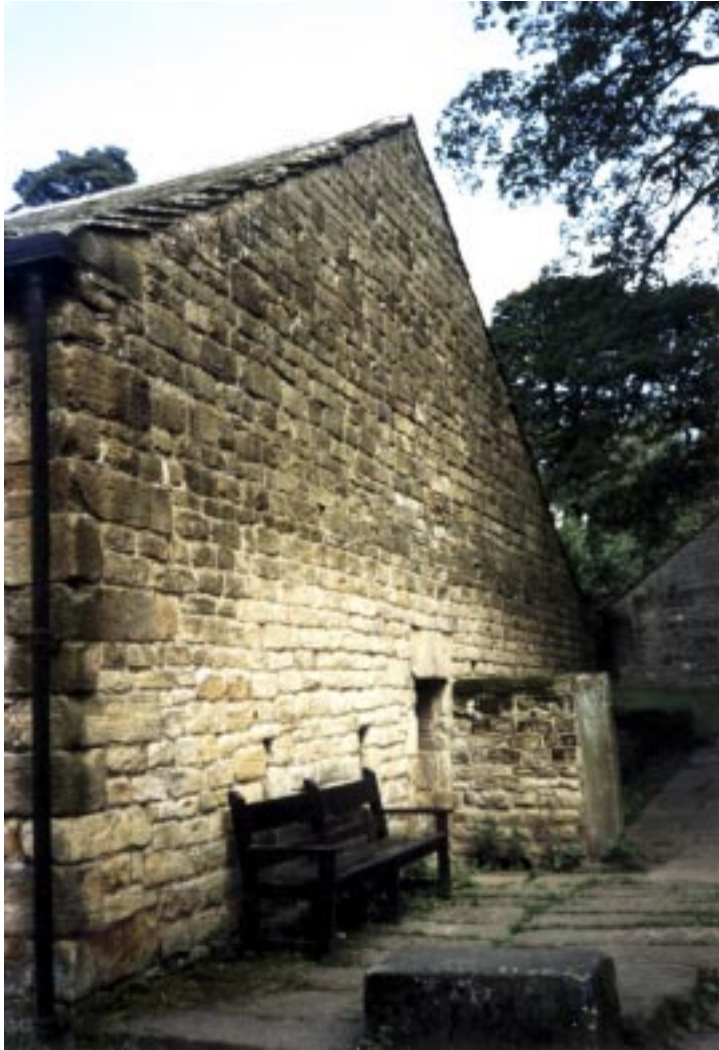
3. South gable with central door opening outwards

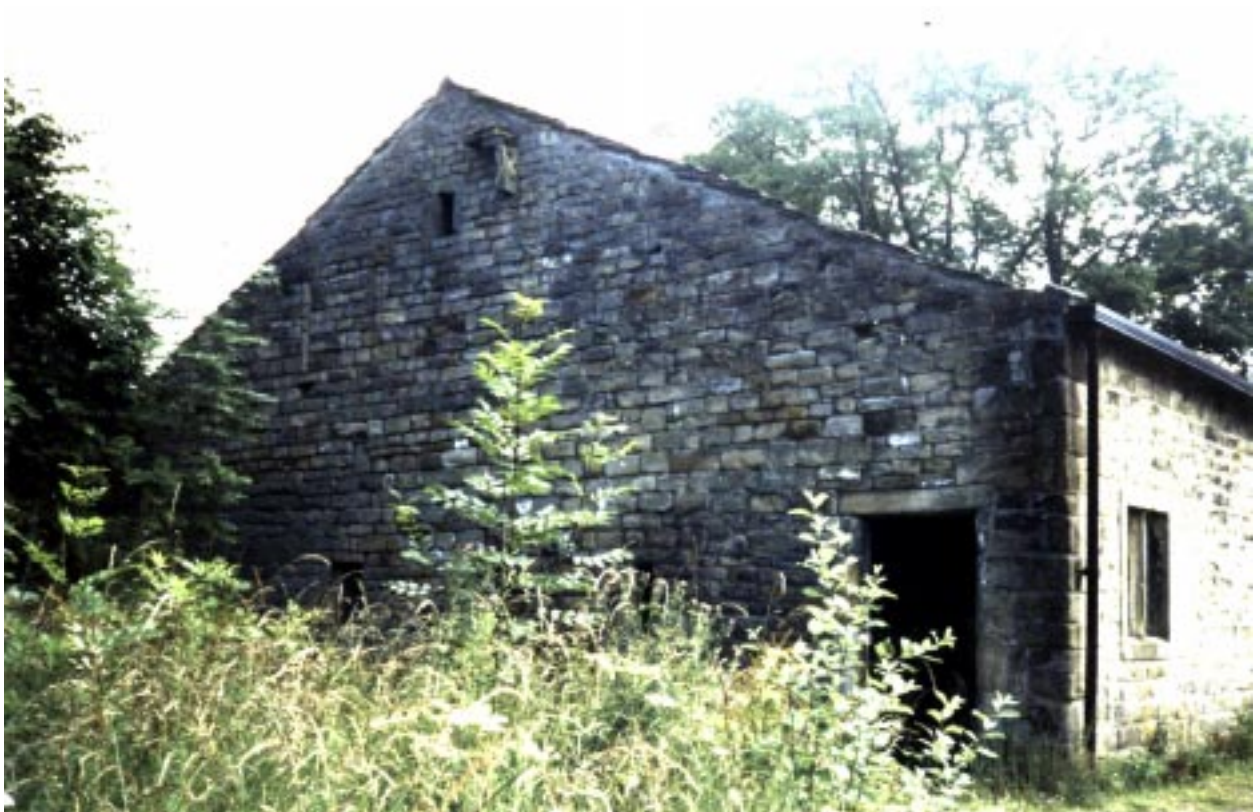
4. North gable, with former door to loft

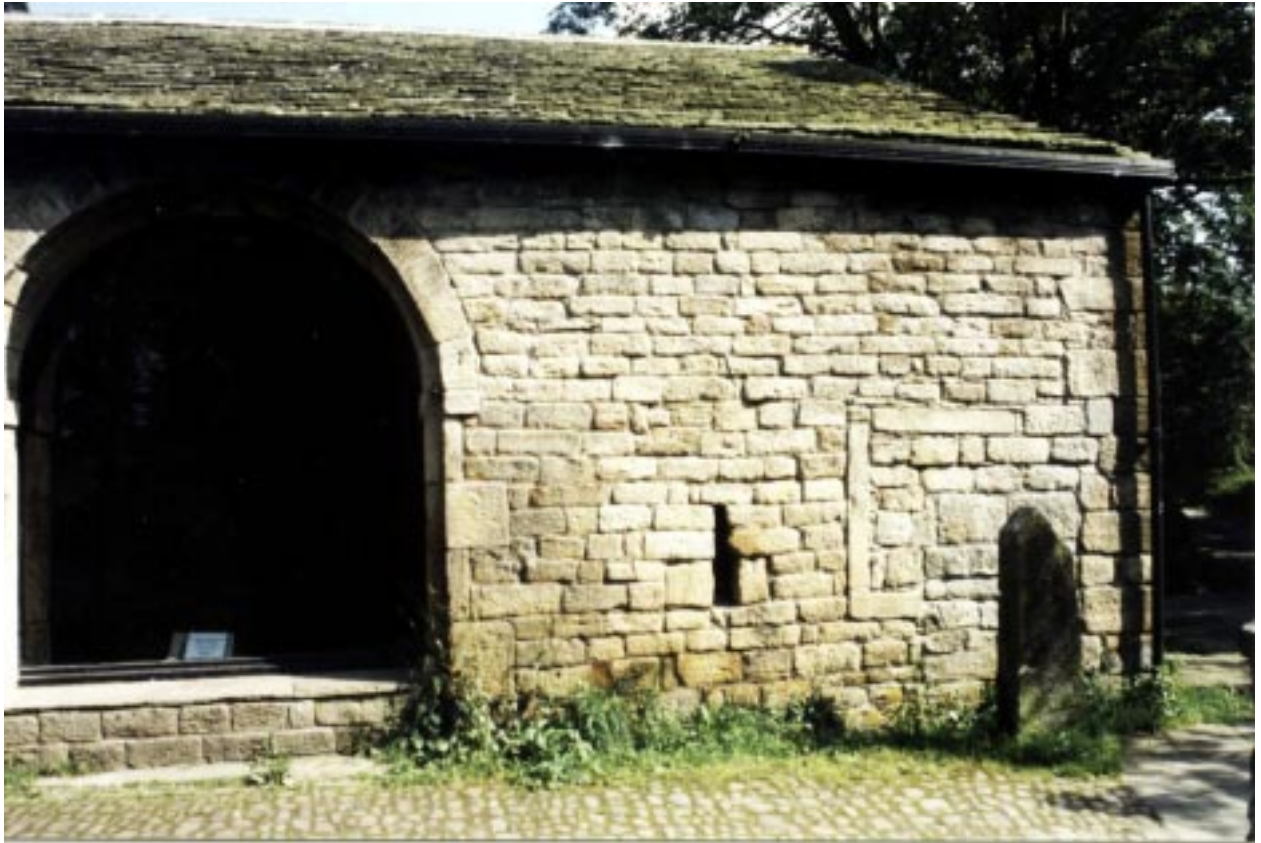
5. 18th-century window replaced by later door to feeding passage, also blocked

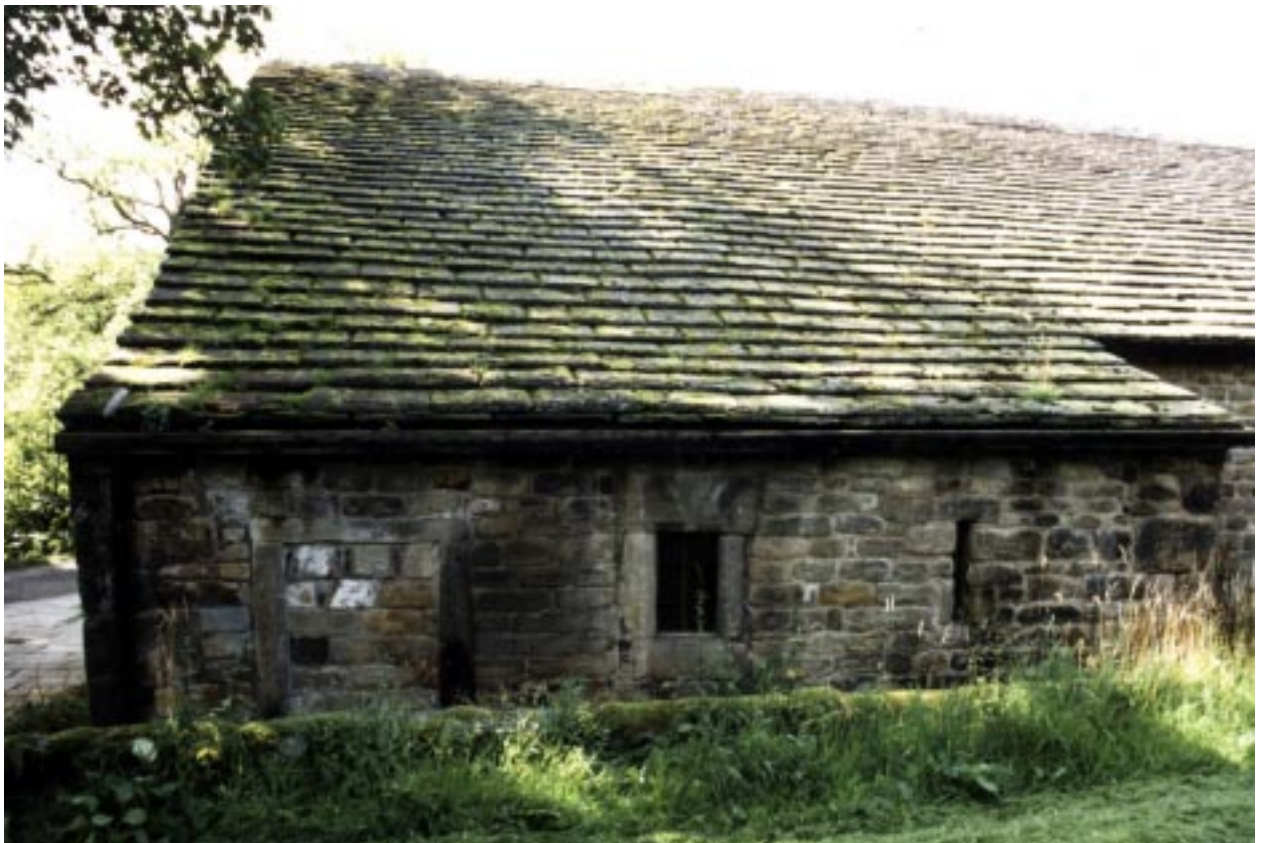
6. Blocked door in outshot probably gave access to feeding passage for cattle

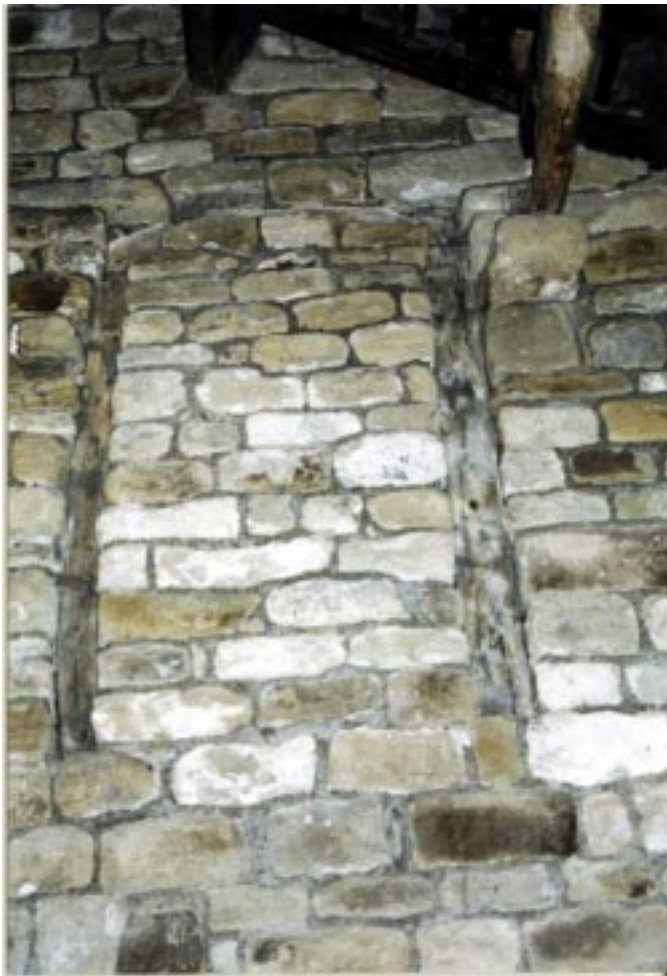
7. Door to former loft over the northern bay

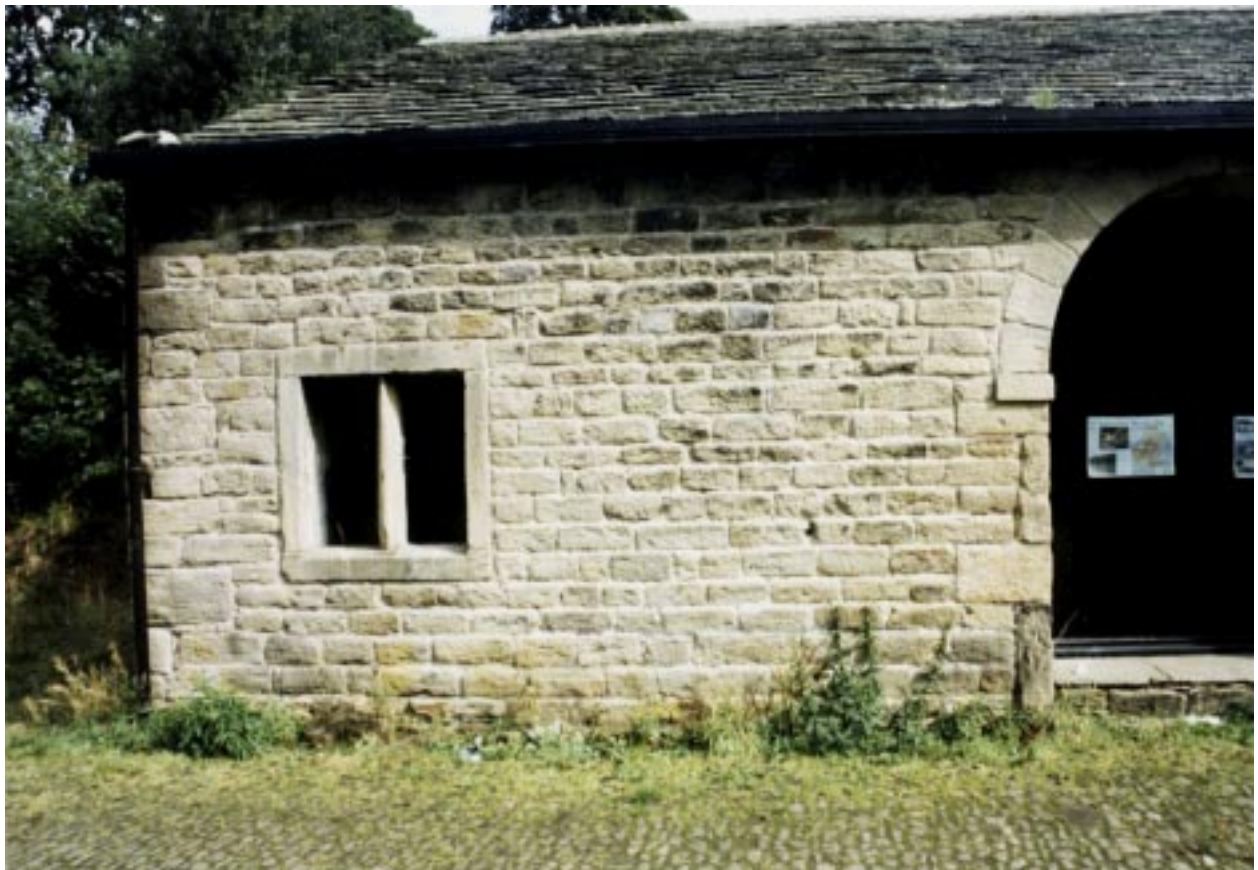
8. One of a pair of 18th-century windows; the south one is now blocked.

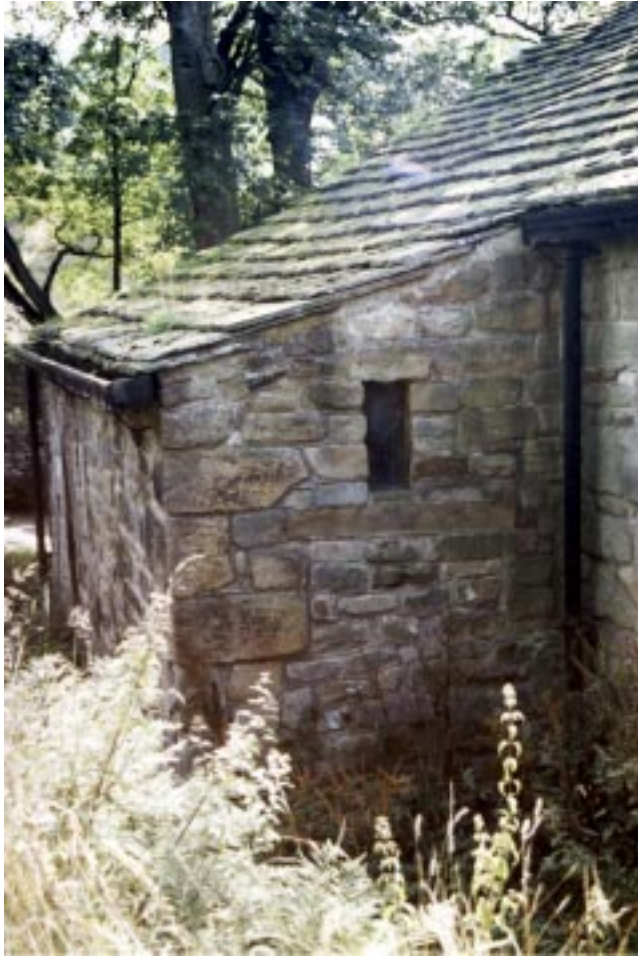
9. Blocked door and new window to outshot-  
alteration of c.1980

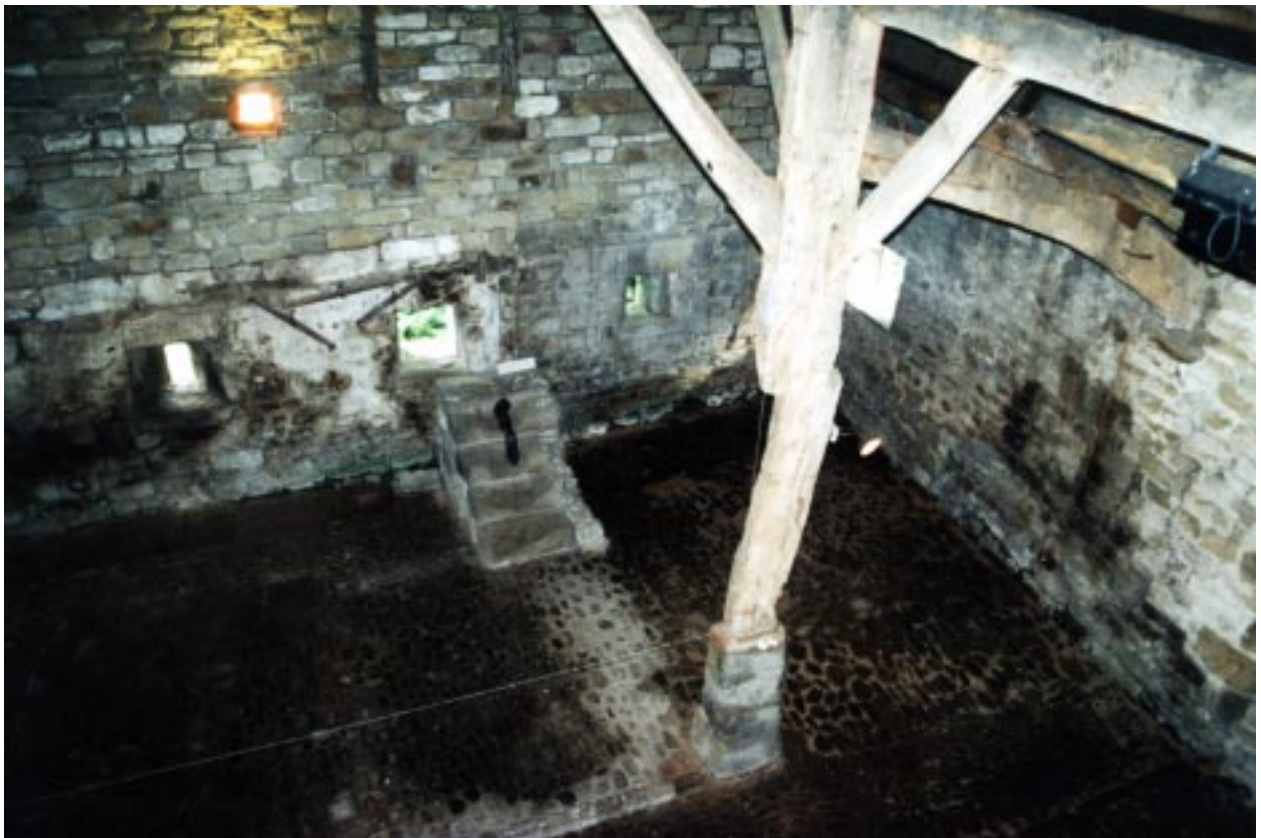
10. Post possibly re-used from a tiebeam

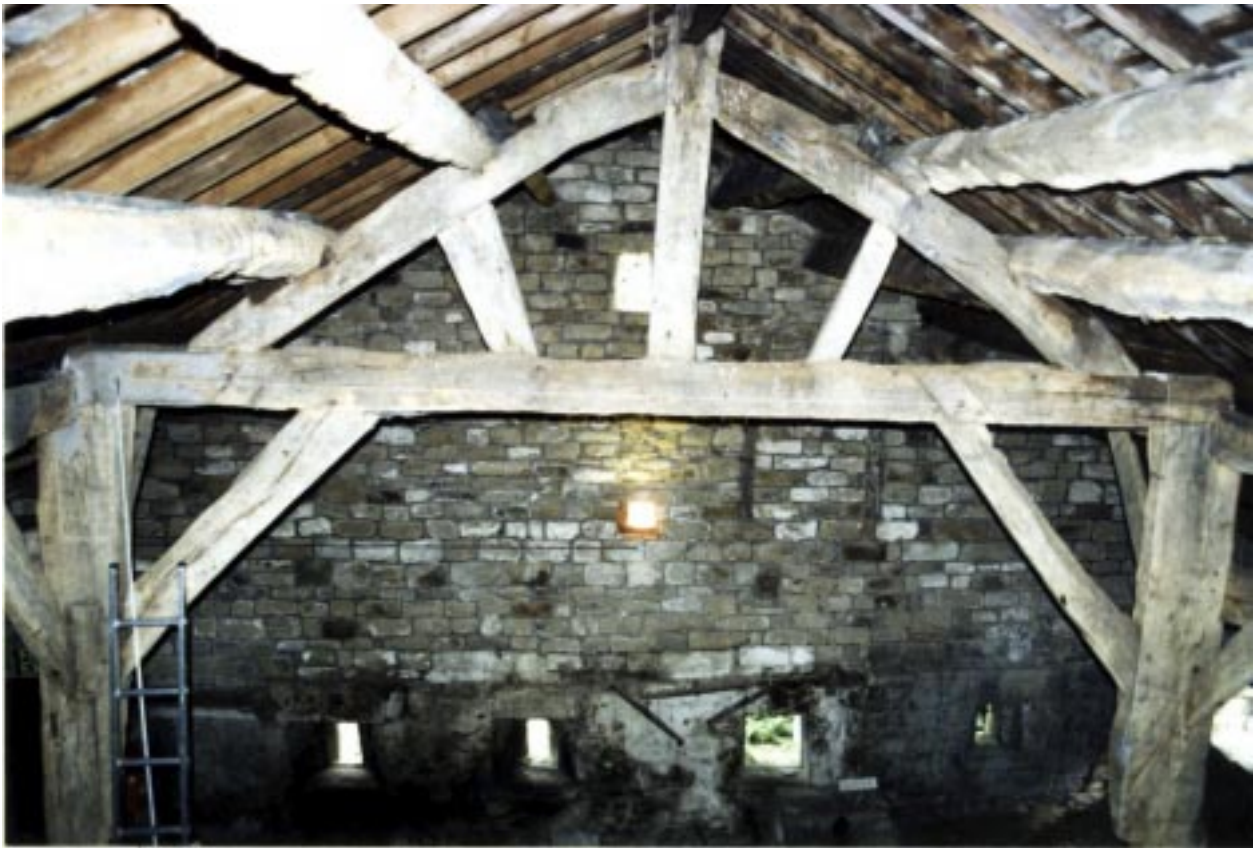
11. Post-medieval trusses have struts flanking the king post.

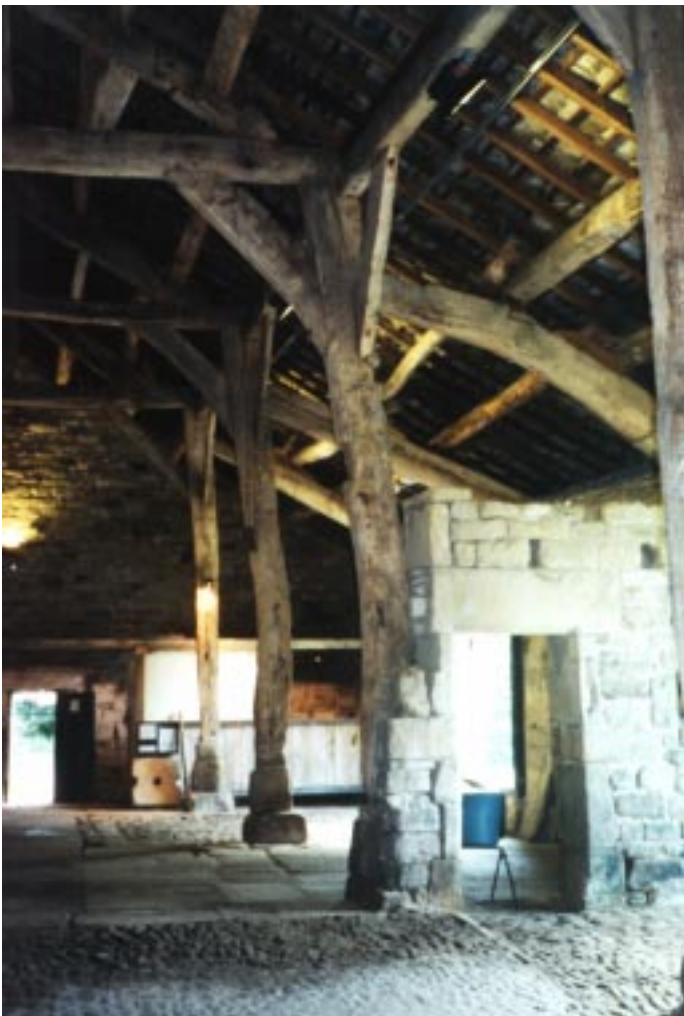
12. In Type III aisled barns, a sloped tiebeam supports the aisle roof

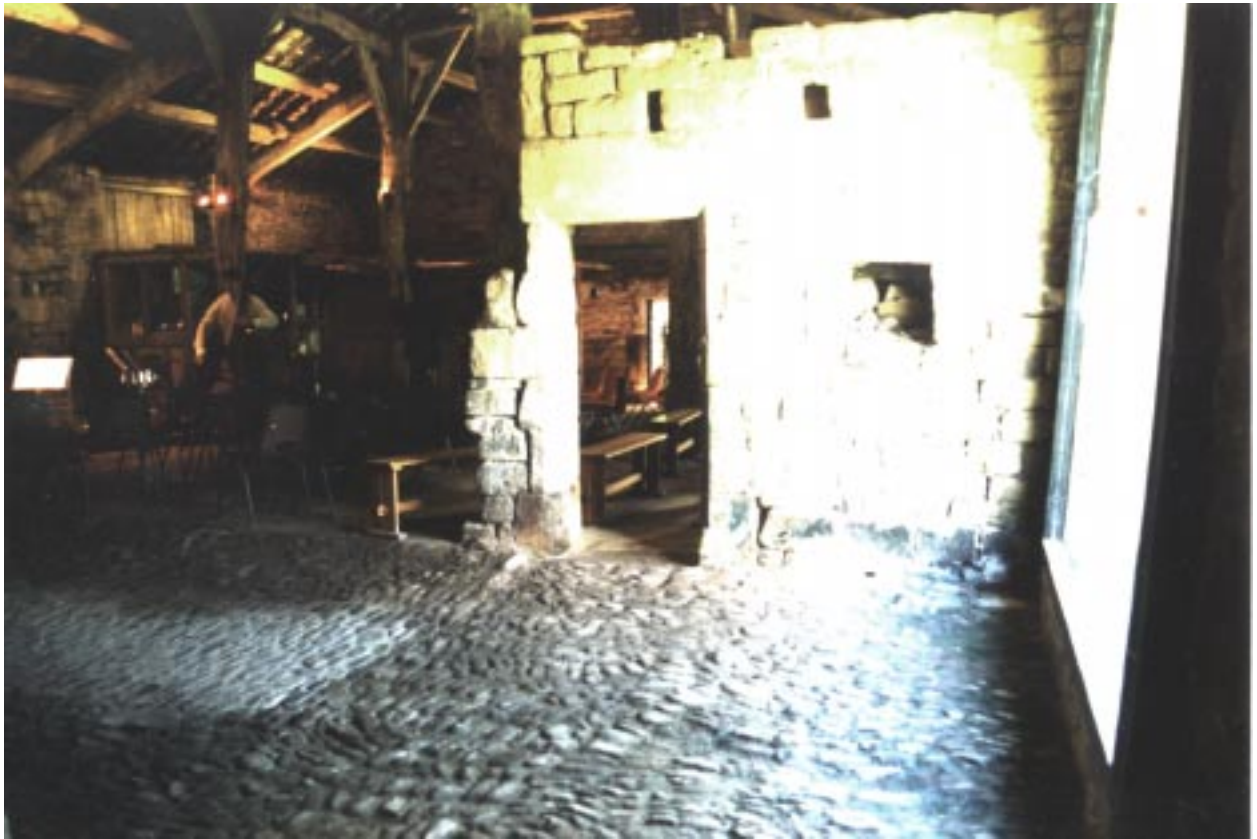
13. Possible doorway to original cattle stalls, with lamp recess to the right

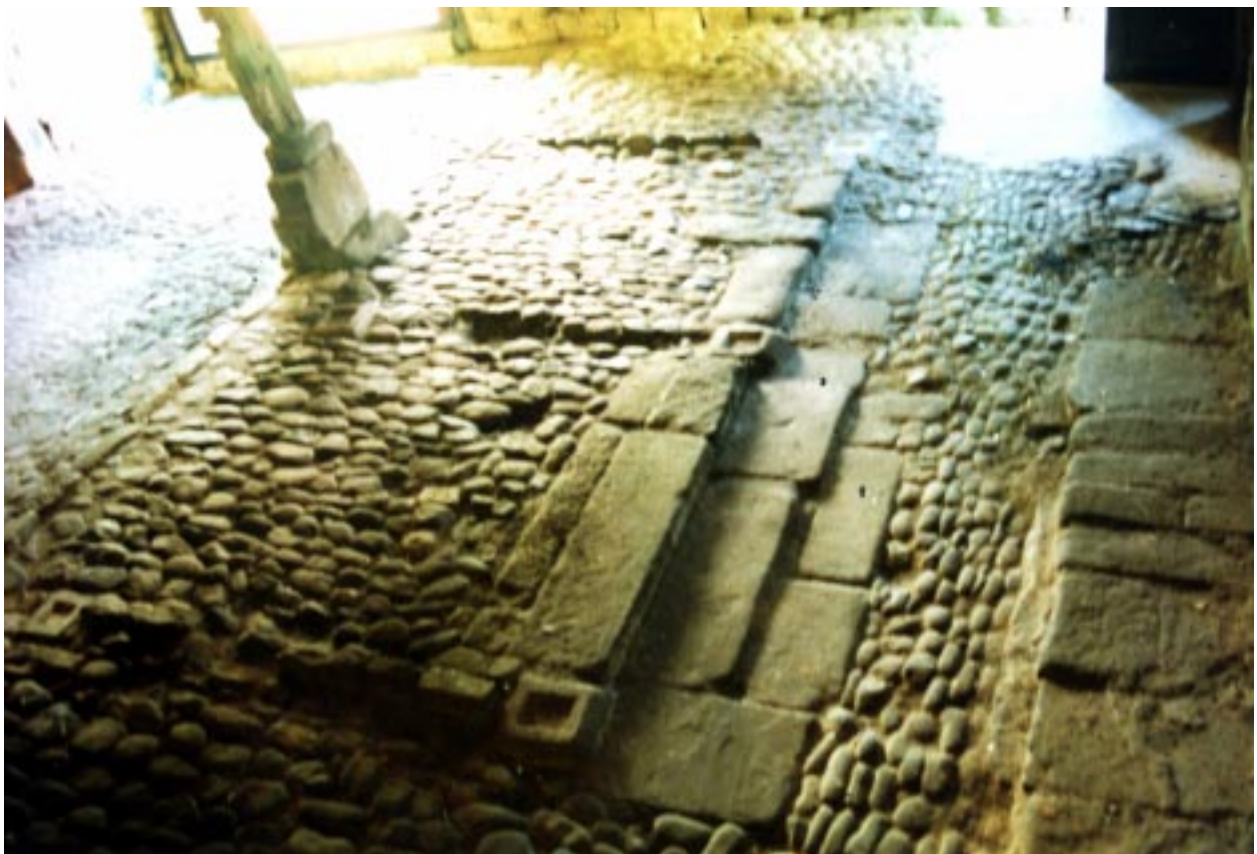
14. Cobbled feeding walk behind cow stalls

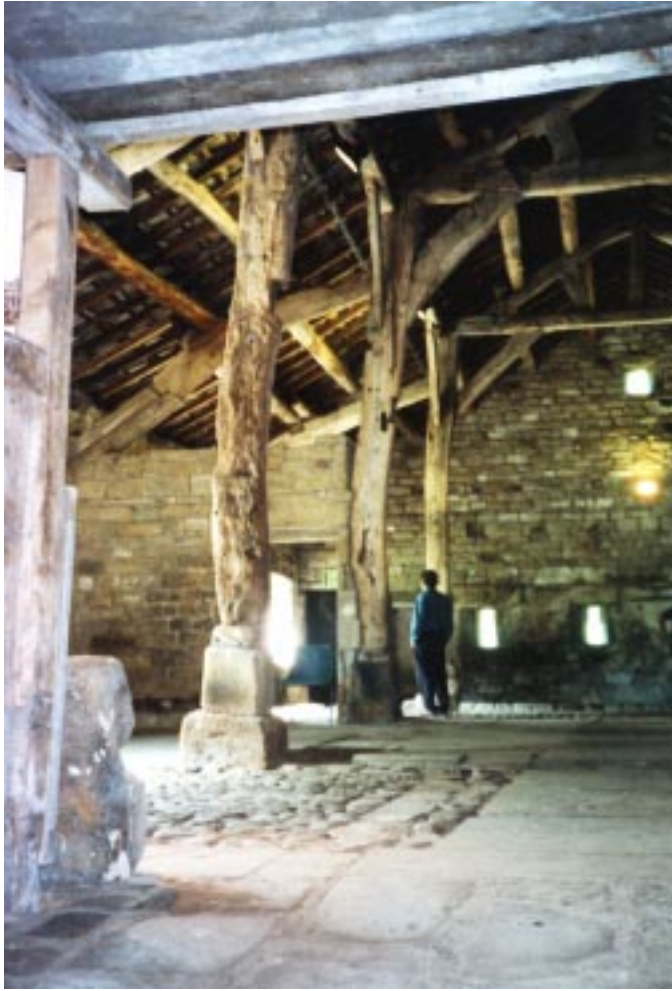
15. Cow stalls may once have occupied the west aisle

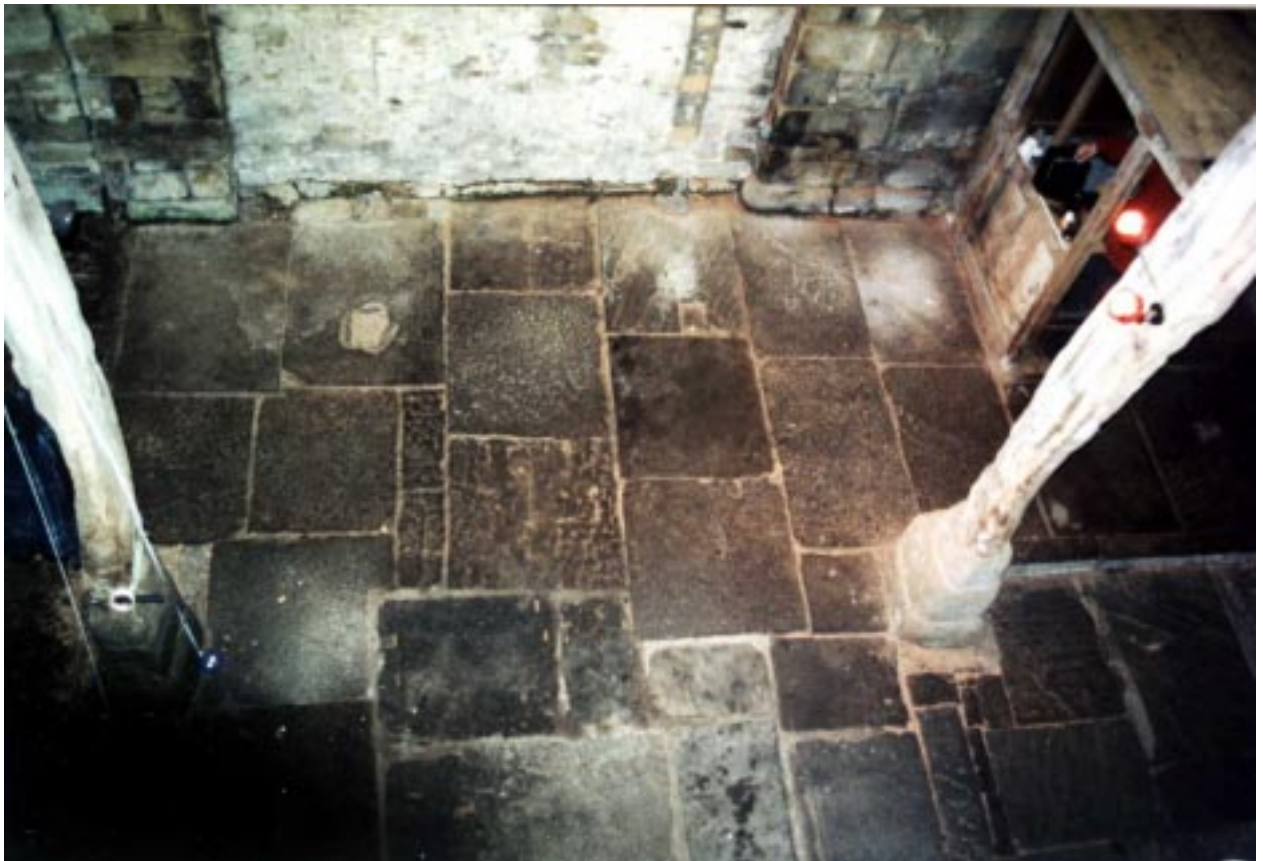
16. Later threshing floor

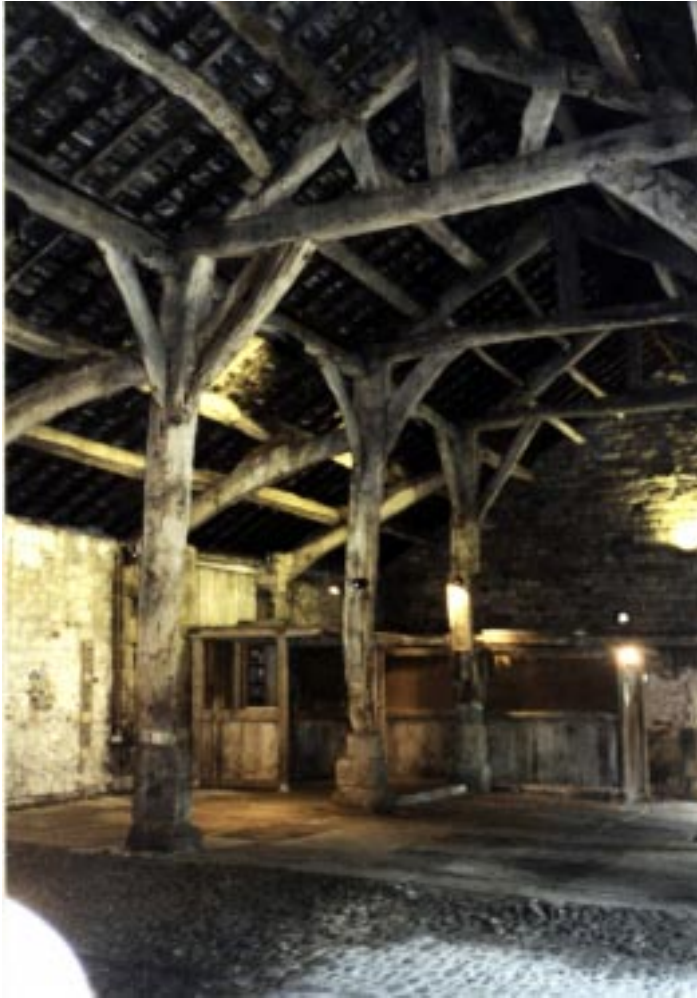
17. Stalls for cattle survive in the southern bay

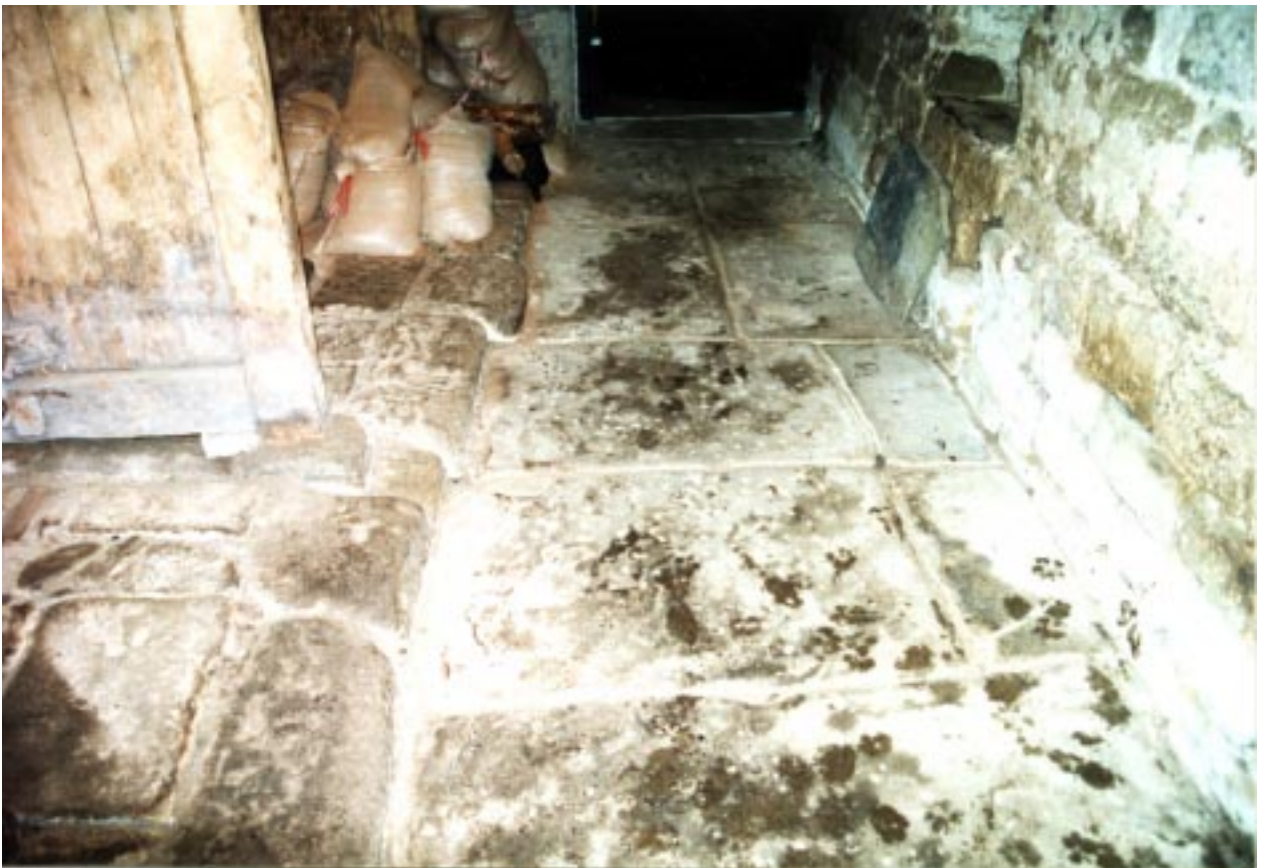
18. Feeding walk behind the southern range of stalls
