**Report on a
UNESCO Mission to Deir Ezzor
for the Restoration of the
Old Souk and the Saray Structure**

**David Michelmore
UNESCO Expert**

July 2008

The Old Souk and Saray Building, Deir Ezzor

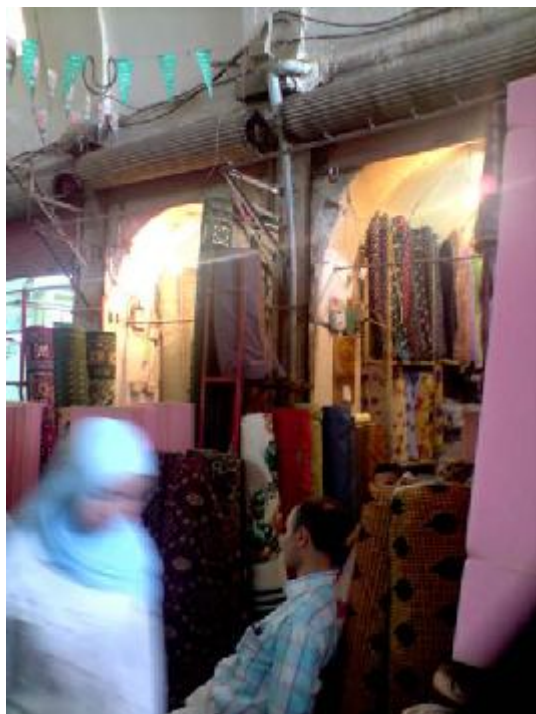
Left, examples of vaulted shops with arched entrances.

Most of the shops have arched entrances, many are vaulted and the souk therefore has considerable architectural qualities which are now not easily apparent. Unlike the Hamidiye Souk in Damascus, for example, the Deir Ezzor souk is no longer central to the local retail and wholesale economy and is largely catering to the poorer population from the city's rural hinterland. This reduced place in the economy has resulted in reduced trading hours and the souk is closed from the afternoon onwards. The UNDP project seeks to re-establish its position in the local economy, but also to diversify its function by reuse of the form khan courtyards clasped by the surrounding streets of the souk, for example for tourism development. However, the proposal to reuse the courtyards will not be viable without upgrading the souk itself. There are two main problems, the first of which prevents the architectural values of the complex

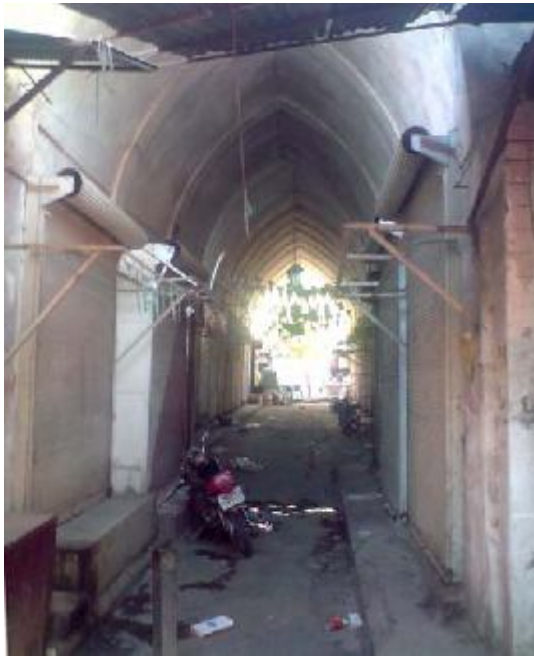
Above left, arched shop entrances are entirely concealed by steelwork when the shops are closed.

from being appreciated, and the second of which is a lack of management which permits serious encroachment on public space. At night, roller shutters conceal almost all the arched shop fronts and present an unremitting façade of steel to the potential visitors, who are envisaged as using the khan courtyards in addition to the shops.

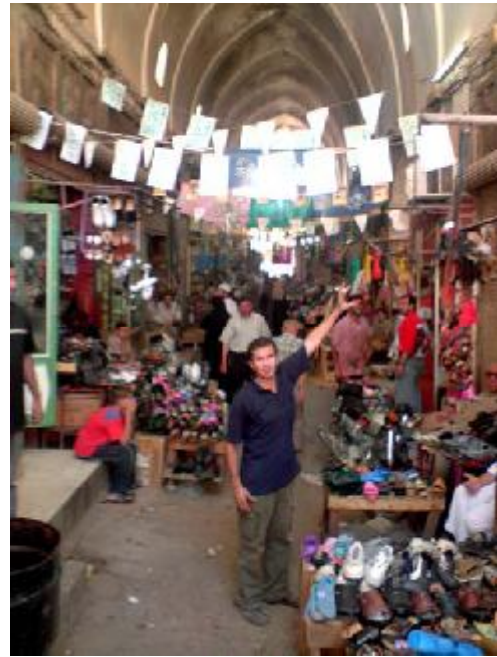
Above right, lack of management allows shopkeepers to use (and block) public space rather than their shops for sales.

Encroachment on public space by shopkeepers and vendors is a major problem in the Deir Ezzor souk (illustrated on p. 5 above), as in public markets in many other cities. In Damascus, following the rehabilitation of Hamidiye Souk in 2002, encroachment by shopkeepers has been prevented, but enforcement is very lax and intermittent in other souks in the city and is at its most acute in Seyidi Rukkaya Souk, because of the volume of pilgrims and other visitors who pass through Bab Al-Faradis. Shopkeepers narrow the street to half its width by placing tables in front of their shops. In open souks (as can be seen in the open sections of the Deir Ezzor souk), encroachment by

UNESCO's experience in other heritage cities has shown that it is possible to make shopkeepers retreat within their shops, if the rule is applied fairly to all. The removal of encroachments not only frees the whole width of the street for pedestrians, but also reduces their number, as shoppers will go inside the shops to buy goods, rather than blocking the way in the street itself. In the case of Hoi An Ancient Town World Heritage Site, Vietnam (arguably the best managed historic town in Asia), the municipality even has a Section for Checking Civilised Behaviour, which is responsible for checking encroachment, noise pollution and other public nuisances. In the case of the Deir Ezzor souk, such an institution would be unnecessary, but nevertheless to truly valorise the souk it will be necessary for the municipality to institute regulations to regulate encroachment on public space in the restored souk and to be serious in implementing such regulations. The daily chaos in Seyidi Rukkaya Souk in Damascus provides an object lesson in the consequences of lax enforcement.

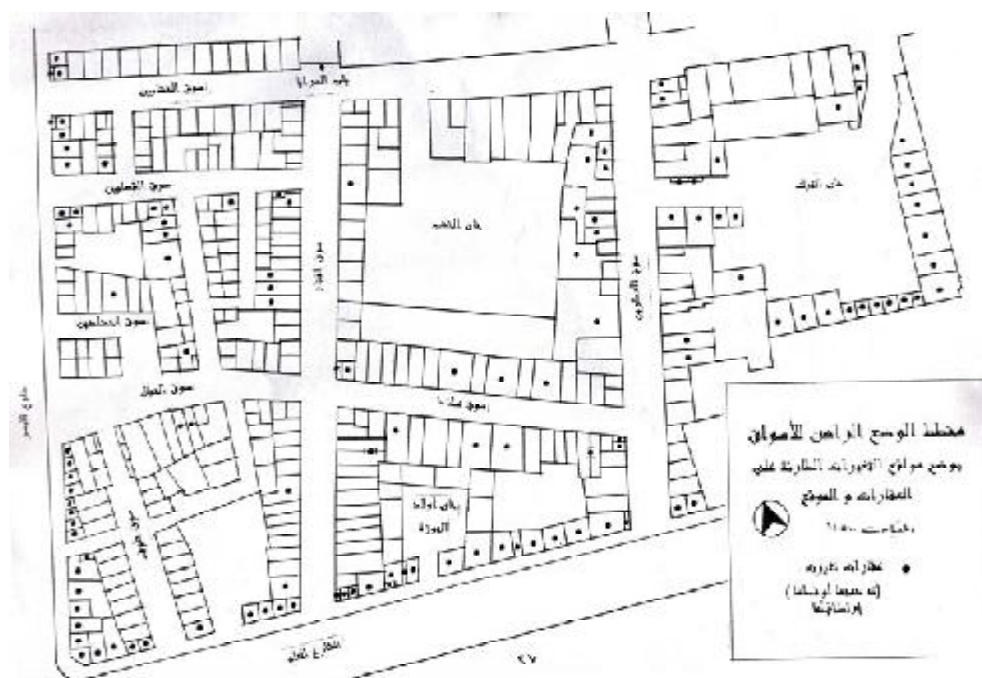
A survey carried out by the project indicates that most of the shops in the souk retain their original architectural character; those that have been altered are indicated with a black dot on the plan below.

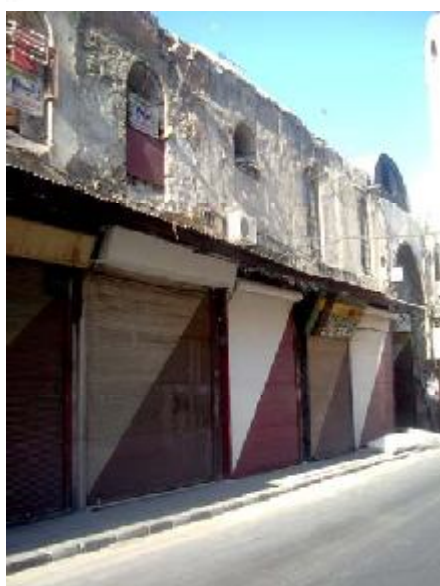
This is graphically illustrated by Midhat Basha souk in Damascus. The survey drawing above demonstrates the underlying character of the arched-fronted vaulted shops, but their architecture is almost entirely concealed by steel roller shutters (*left*), a modern intrusion into the streetscape, directly paralleling the situation in the souk at Deir Ezzor.

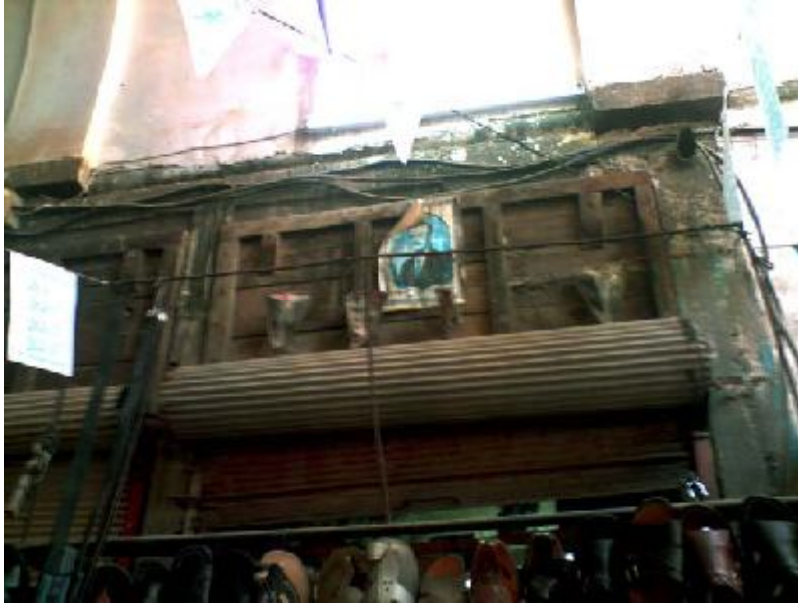
There is some evidence to suggest that demountable shutters of this type were used in the Deir Ezzor souk, as two shops appear to show the remains of such shutters above the modern steel roller shutters (*left*).

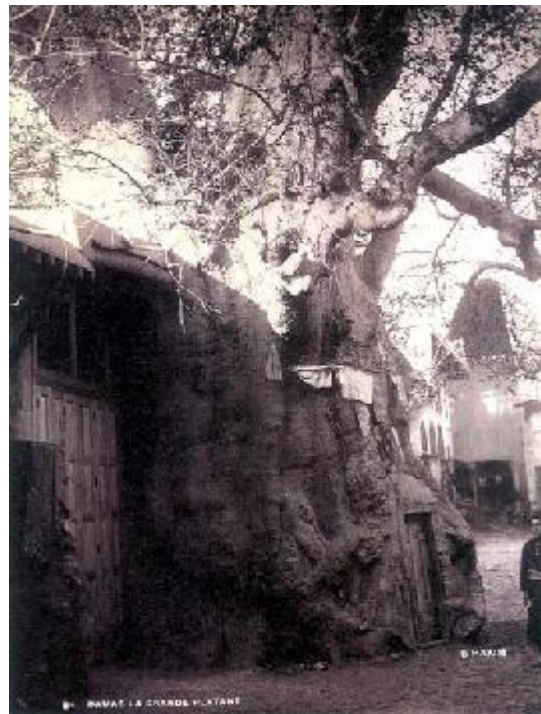
Above, archive photo of the giant plane tree which formerly stood in Souk Sarouja; just to the left, a shop front closed with folding iron shutters is clearly visible.

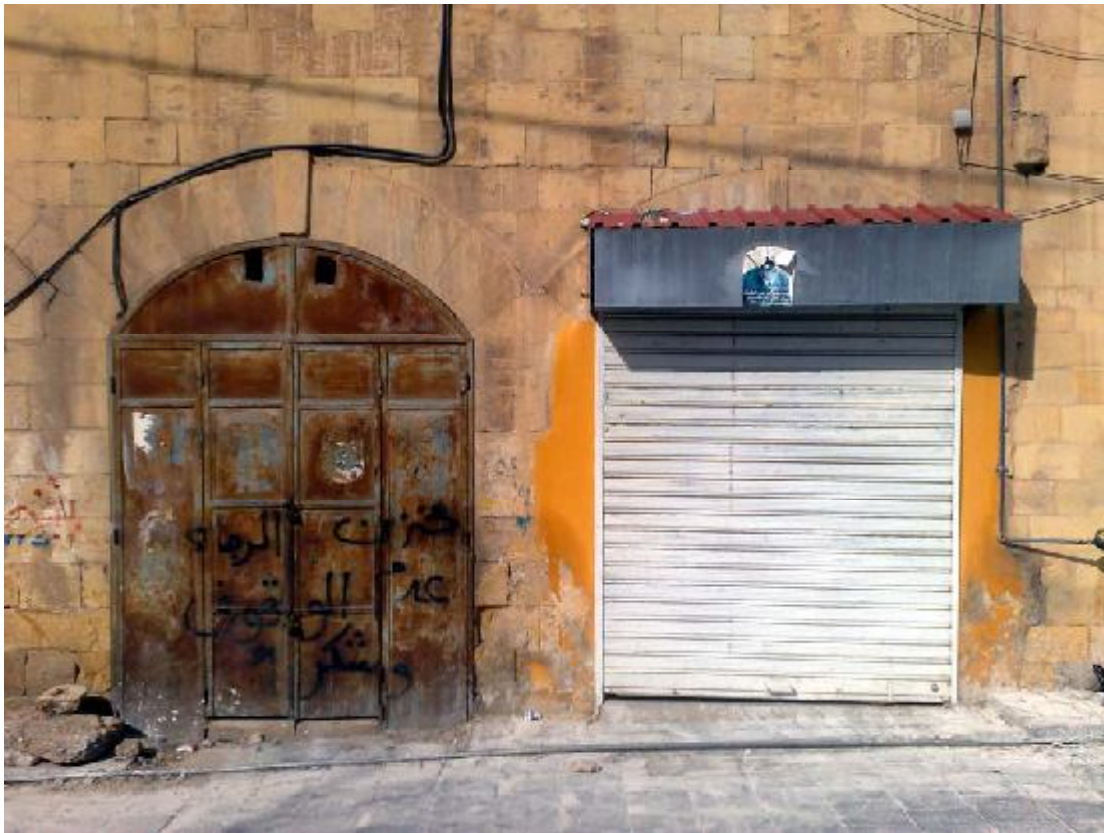
Above, pair of historic shops in Salt, Jordan. On the left, historic iron shutters leave the architecture visible, while in the case of the shop on the right, the modern face-fixed roller shutter completely conceals the arched shop front. In this case, the leaves of the iron shutters are wider than those identified elsewhere and recommended for use in Deir Ezzor.

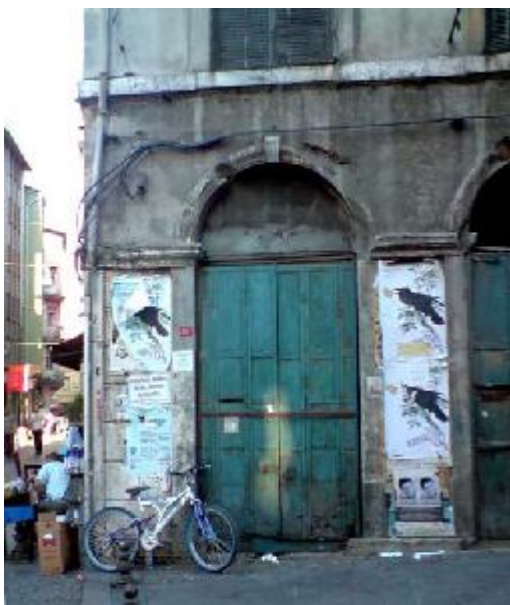
Left, pair of shops in the Fish Market, Beyoğlu, Istanbul. The shop on the left shows how, in shops with arched entrances, the folding shutters were normally fitted under a fanlight which allows light into the shop itself.

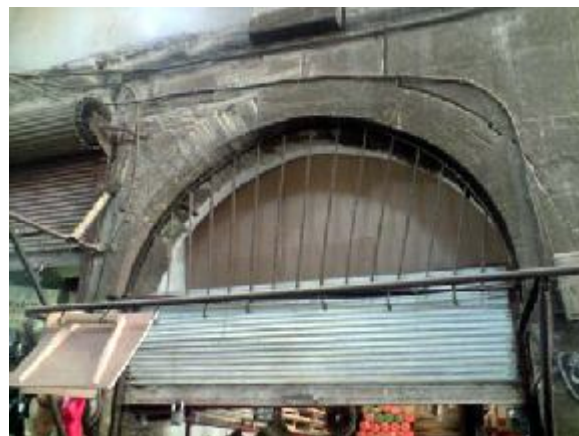
Below, old iron grill closing a fanlight arch in the Deir Ezzor souk.

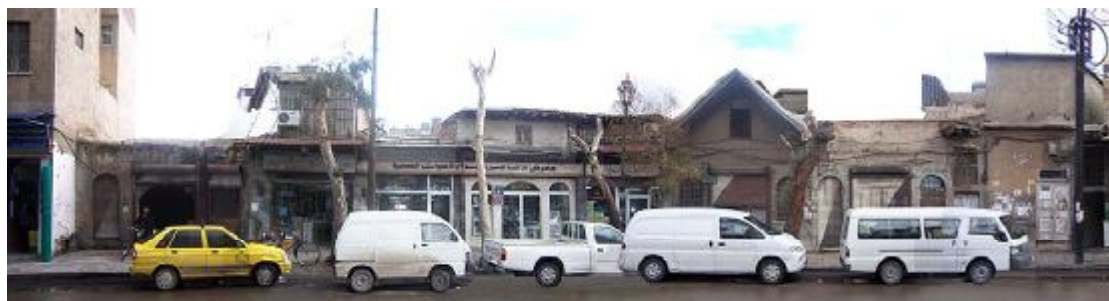
Above, a row of Ottoman-period shops and workshops on the south side of Malik Faisal Street, as existing; *below*, the same buildings as they would appear with later accretions removed and with the openings fitted with sideways-folding iron shutters.

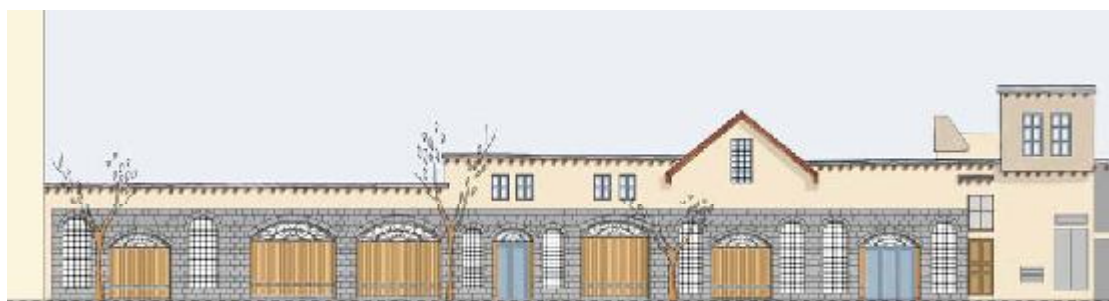
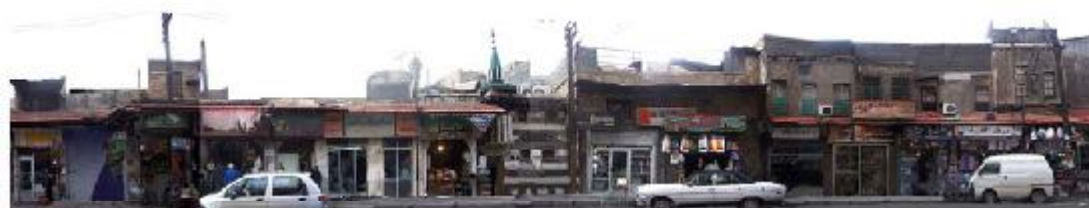
Above, row of Ottoman- and Mamluk-period shops on the north side of Malik Faisal Street, as existing; *below*, the same buildings as they would appear with modern accretions removed and with the arched shop fronts fitted with sideways-folding iron shutters.

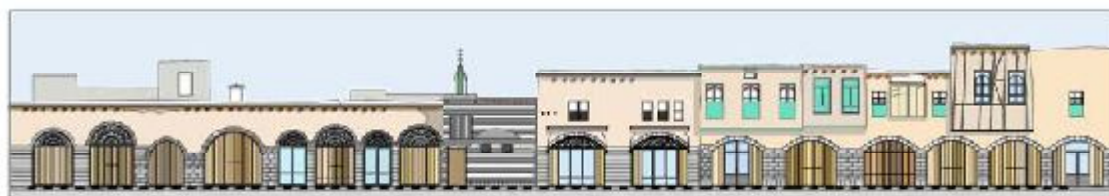
The MAM project has also carried out a study to show how sideways-folding iron shutters could be fitted to every kind of shop opening found in Midhat Basha in Damascus (*below*), paralleling the examples or original shutters in Salt and Istanbul illustrated on p.8 above.

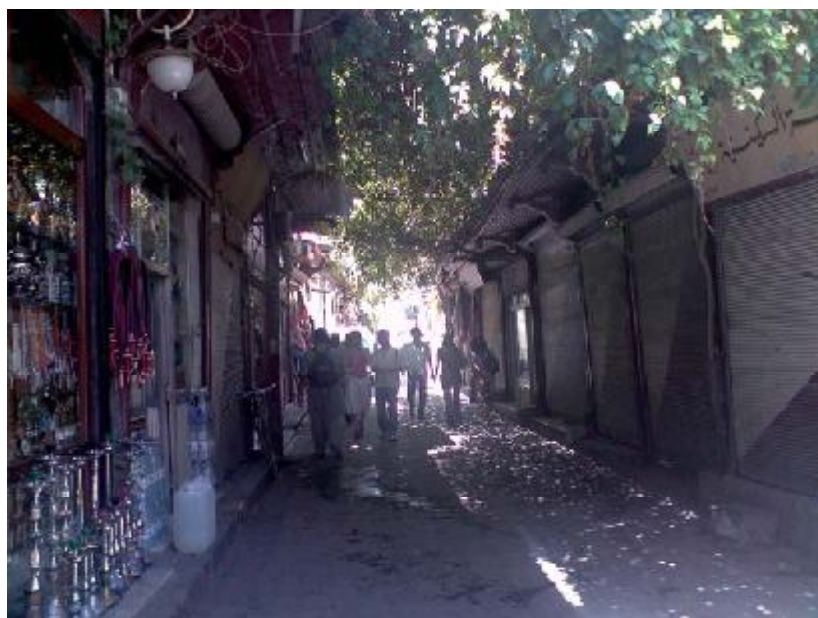
Damascus also provides examples of enhancement schemes where mistakes have been made. Kaymariye Street was subject of an enhancement scheme in the 1990s, but the need to remove the face-fixed roller shutters was not addressed. In consequence, the scheme had a greatly reduced impact (*left*).

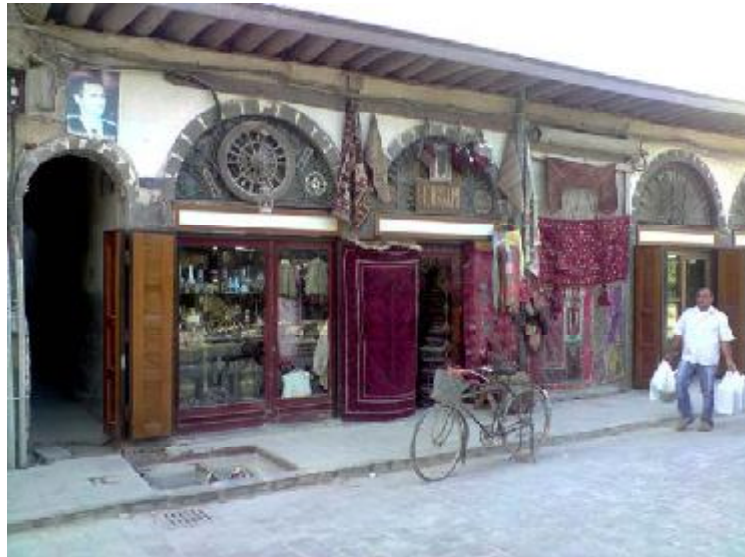
The current enhancement scheme for Souk Midhat Basha, Damascus, involves replacing steel roller shutters with folding wooden shutters bound by steel frames. It is impossible to make wooden shutters as thin or the leaves as narrow as those of the historic iron shutters illustrated above. The shutters are difficult to fold away and tend to project forward and block the pedestrian walkway, as can be seen in the example on the extreme right of the illustration above.

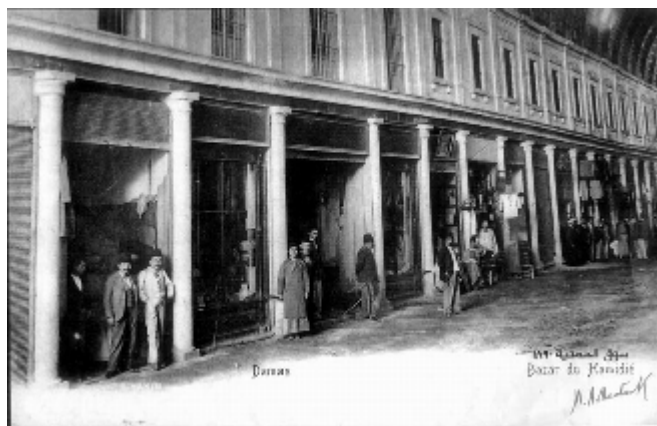
Some large souks, dating from the very end of the Ottoman period, contain shop fronts designed from the very first to be closed with roller shutters. The shutters can be clearly seen in the archive photograph of Souk Al-Hamidiye, Damascus (*left*). These shutters do not roll up into a large shutter box, as modern roller shutters do, but up under the roof of the shop. Most

importantly are fitted in check behind the facade and do not conceal the

architecture, as is the case with modern face-fixed shutters with protruding shutter boxes. A few shops in the Deir Ezzor Souk were also designed in this way (*right*) and in these cases roller shutters should be retained. However, the example of Balat Market (Istanbul), discussed below, demonstrates the visual advantage of using shutters made of steel mesh rather than solid

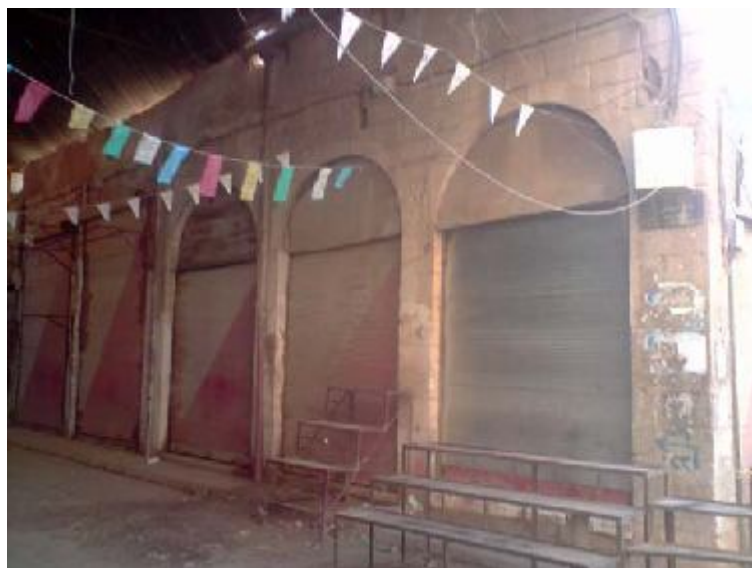
shutters, as shown here. In the case illustrated, the visual appearance would also be much improved by the reinstatement of the wrought ironwork in the fanlight which will certainly originally have been present.

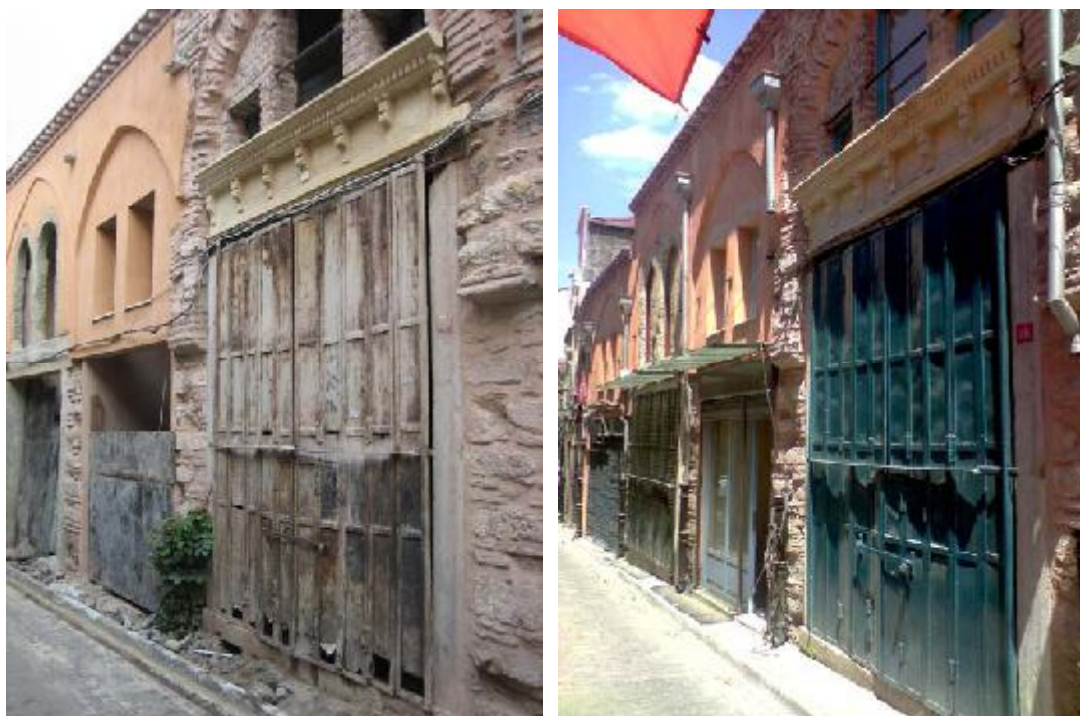
Two of the shops retained their original Ottoman-period sideways-folding iron shutters, which have been restored, illustrations of one of which are presented below.

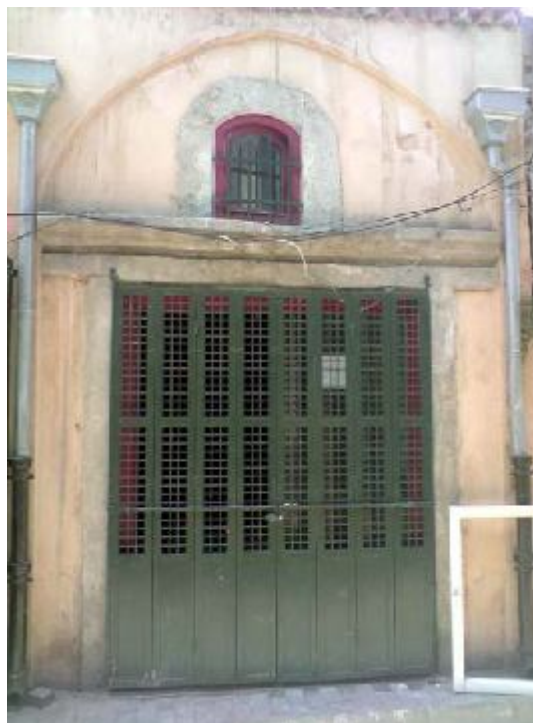
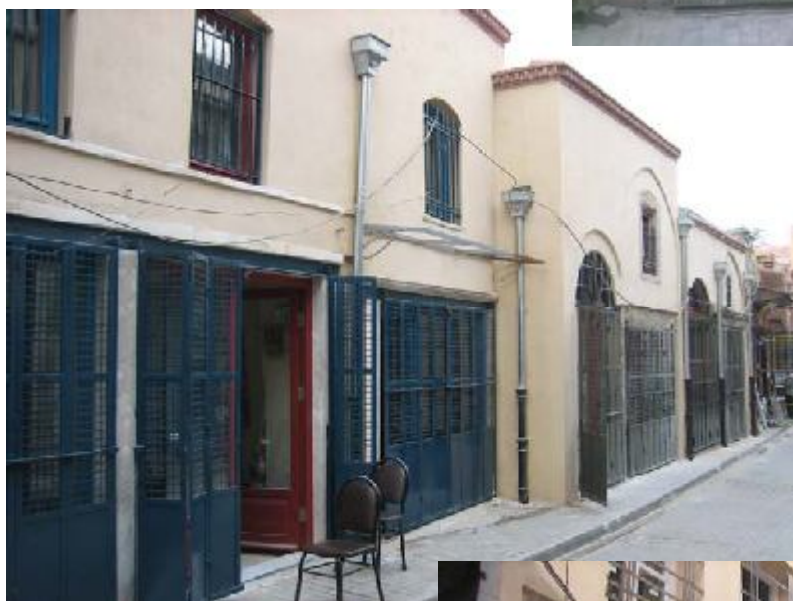
Replacement shutters have been fitted in all cases where such shutters could be shown to have originally existed by the survival of the pintles in the jambs of the shop-front openings, which supported the shutters at their outer edges. However, a modern variation has been introduced, in that the upper part of the shutters have been restored as an openwork grill rather than solid ironwork (*right and below*).

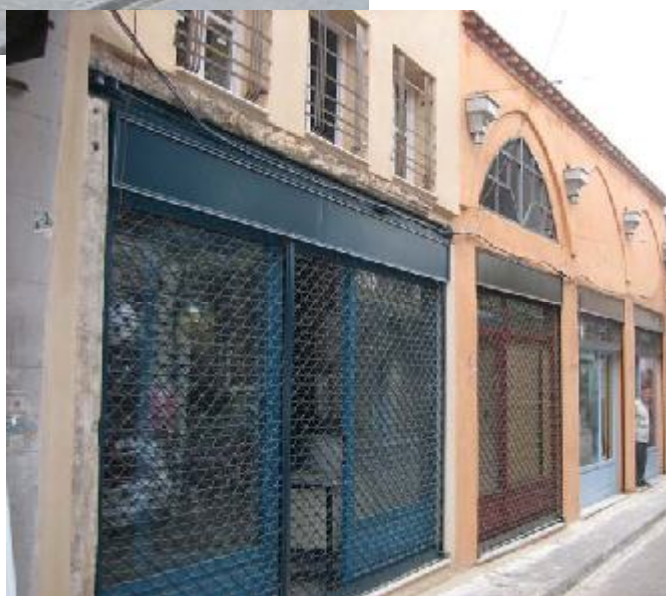
In other cases, roller shutters were fitted within the shop-front openings, but with the shutter boxes flush with the shop façades rather than projecting beyond the face of the buildings and therefore still allowing the architecture be seen (*right*). In addition, roller grills rather than solid roller shutters have been fitted.

It is recommended that both these solutions should be considered for the Deir Ezzor souk.

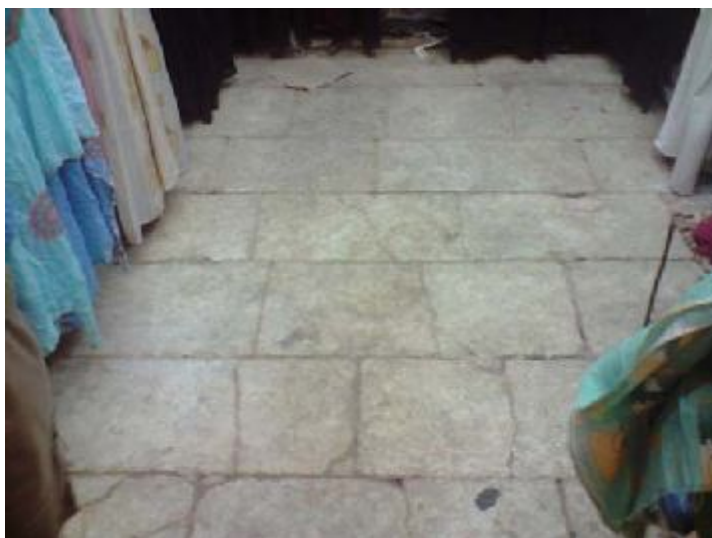
The writer was informed that the souk streets were originally unpaved. Some shops retain their original limestone paving slabs, which could be copied to provide an attractive new walking surface for the whole souk.

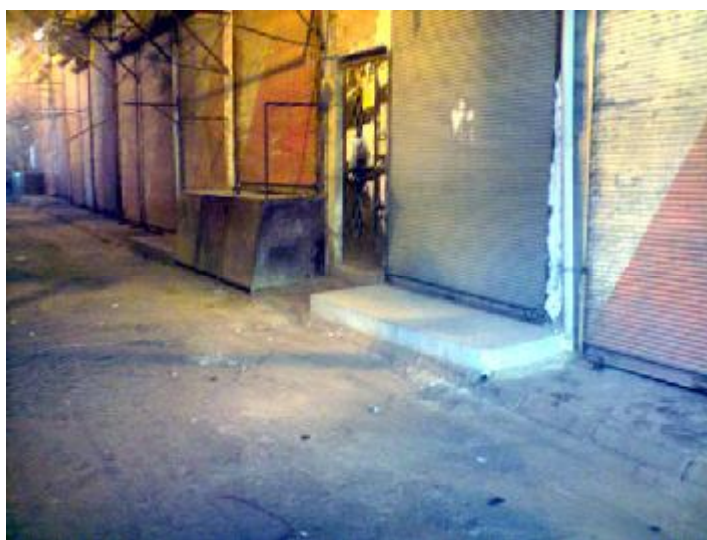
In addition, it will be necessary to remove encroachments such as steps and storage containers projected into the public streets (*right*), so that the streets are fully restored for public use. A similar policy was successfully implemented during the restoration of Hamidiye Souk in Damascus.

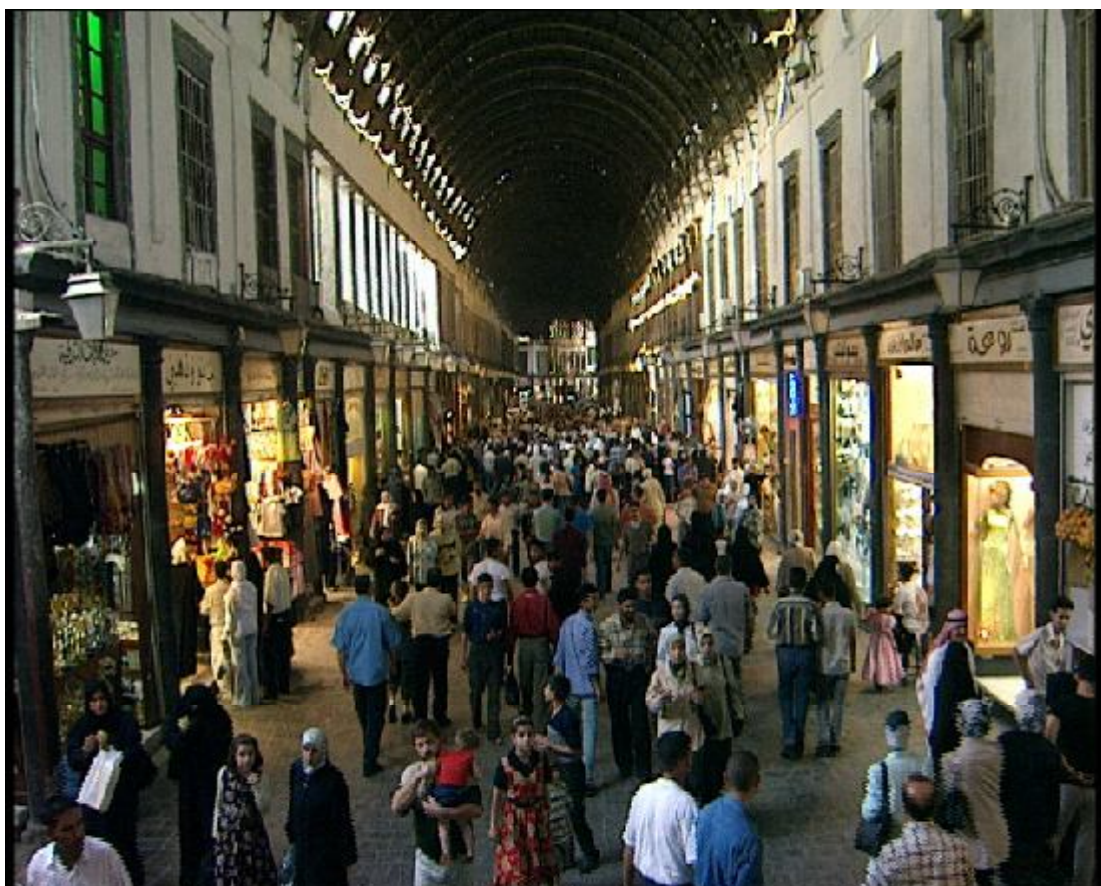
The regulations to manage the souk after restoration will also need to cover questions of signage. As was implemented in the Hamidiye Souk restoration in Damascus (above), it is recommended that only painted wooden signs should be permitted and that illuminated plastic signs should be banned. Similar policies are pursued in other

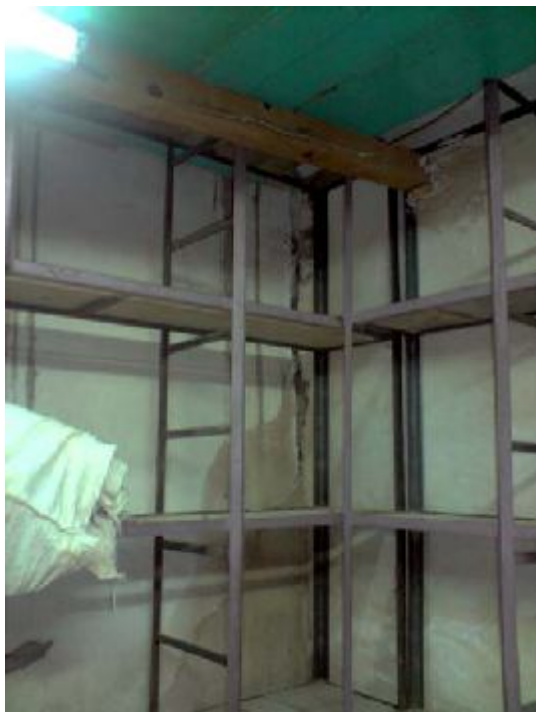
Sections of the Deir Ezzor souk show significant structural problems, probably connected with subsidence of the foundations. Such problems have been linked to the problems of surplus water used by butchers' shops, which it is proposed should be moved out of the souk. This will certainly be a good idea as part of the proposal for the overall valorisation of the souk, but the structural problems should be checked by an engineer experienced in the assessment of historic structures. As an immediate step, tell-tales should be fixed over the cracks to establish whether, or how much, movement is currently taking place.

Left, crack showing the separation of the back wall from the cross wall in a shop in the souk.

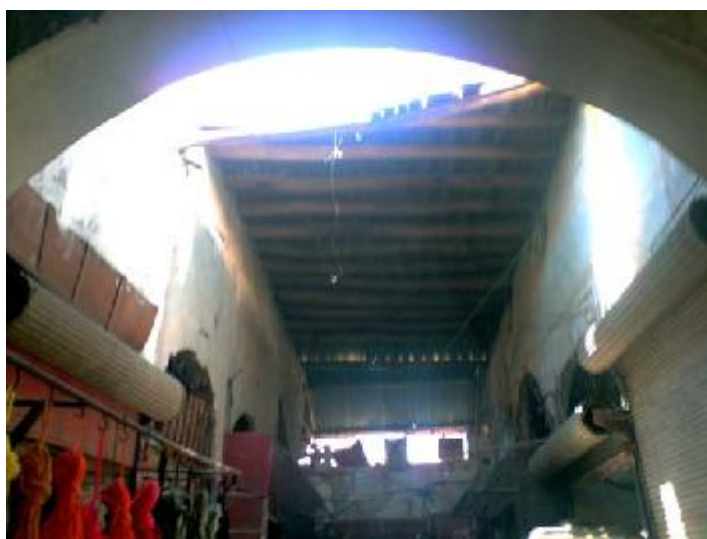
A second problem has been identified in a section of the souk roofed with timber beams rather than by a vault (*right*). Here, the walls projecting above the arched shop fronts, show signs of inward rotation, where they are not restrained by the outward thrust of the vaults. This problem also requires investigation by a specialist structural engineer.

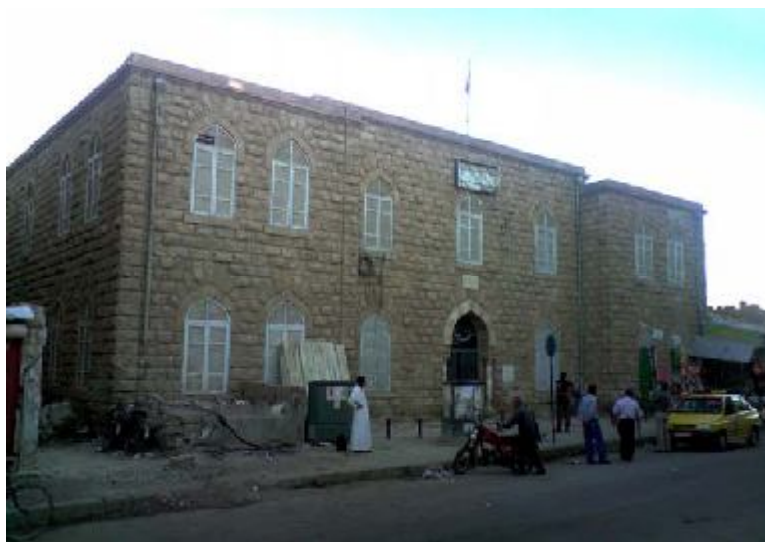
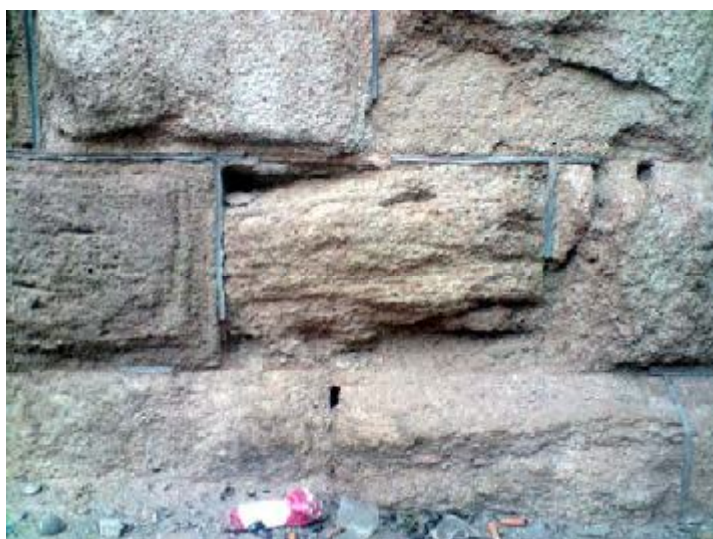
The Saray building (*right*), which was formerly used as a court and subsequently used as a museum, dates from the first half of the 20th century. It has a rectangular plan with two flanking wings with a slight projection. The first floor and the flat roof are supported on jack-arches. The long corridor on the first floor is lit by clerestory windows and the ground floor corridor beneath by borrowed light through glass floor lights.

The walls are faced with coursed, rock-faced, tightly jointed, masonry in what appears to be a soft, oolitic, limestone.¹ The masonry itself is bedded in a pinkish lime mortar, but the elevations have been pointed in an impervious hard grey mortar which is probably cement-based. In consequence, the stonework cannot breathe through the mortar joints, as it should, but the wall is

perforce absorbing and releasing moisture in different atmospheric conditions, in addition to capillary action, through the stones themselves, which has set up a severe cycle of salt damage and decay at the feet of the walls (*above left*).

Hard cement mortar like this is usually superficial and falls out and the best course of action is often to wait until this has happened. However, in this case the wall has

been deeply pointed, the joints are narrow and the pointing is firm. The mortar used for pointing is so damaging to the wall that **it is recommended that an experiment should be carried out to see if it could be cut out with an angle-grinder without damaging the arisses of the adjacent stones. If this is not possible, it should be left. The bottoms of the walls should be repaired by replacing the decayed stones, which should be laid in a lime mortar matching the lime mortar of the original wall.** There is no easy and permanent solution to this problem, which is exacerbated by the raising of the level of the street pavement. Under no circumstances should the bottom of the walls be faced with stone tiles', as has been done in the case of the historic police building in the Saray complex.

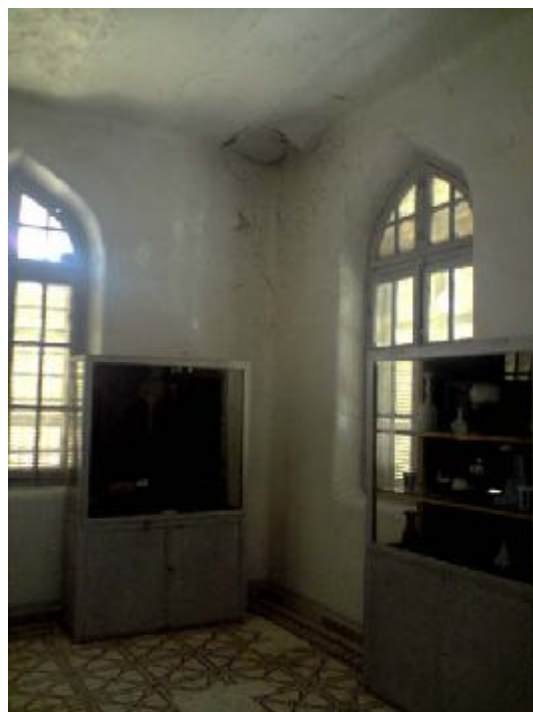
On the first floor, the south-eastern corner of the Saray building has cracks which suggest past or current movement in the masonry. This should be monitored by tell-tales to establish if movement is continuing and should be inspected the structural engineer at the same time as more serious problems in the souk complex and the barracks building. On the south-west corner of the first floor, there is evidence of water penetration from a leak on the roof (*right*). In neither case are these problems visible on the ground floor, suggesting that they are probably not serious.

The overall condition of the Saray building appears to be fair. The plan, which has a centralised circulation based on long corridors on each floor, and the structure, with the floor supported by jack-arches, suggest that it will be suitable for its proposed use as a multi-purpose cultural centre and that the floors should be up to the loads that such a use will impose.

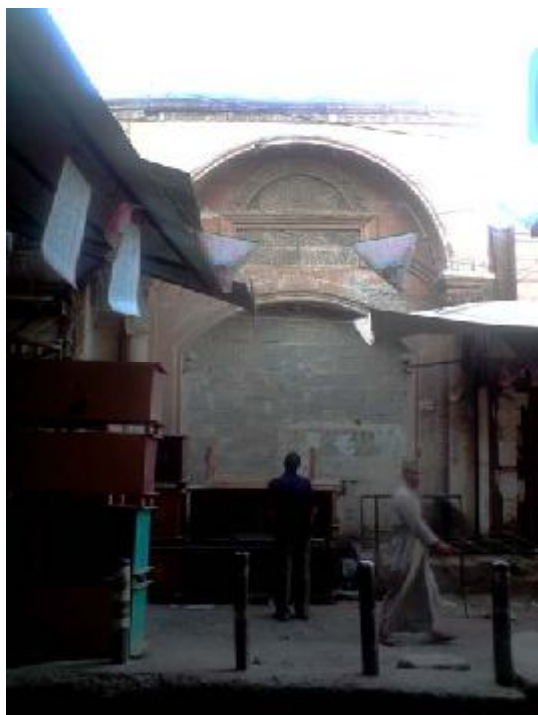
The Ottoman-period Saray gateway, which is at present bricked up, formerly provided access directly from the northern end of the souk into the former barracks courtyard and legal and administrative complex beyond. This impressive, monumental, structure has an inscription dated A.H. 1307. The vaulted structure to the rear of the gateway, on the courtyard side, has mostly collapsed and the area is filled with rubble. There is no problem in reopening the gateway, but the rear structure will require reconstruction, if that is the decision taken, or the rear portion could be conserved in a ruinous and the gateway itself just opened up.

Above left, southern, front, elevation of the Saray gateway, facing the souk.

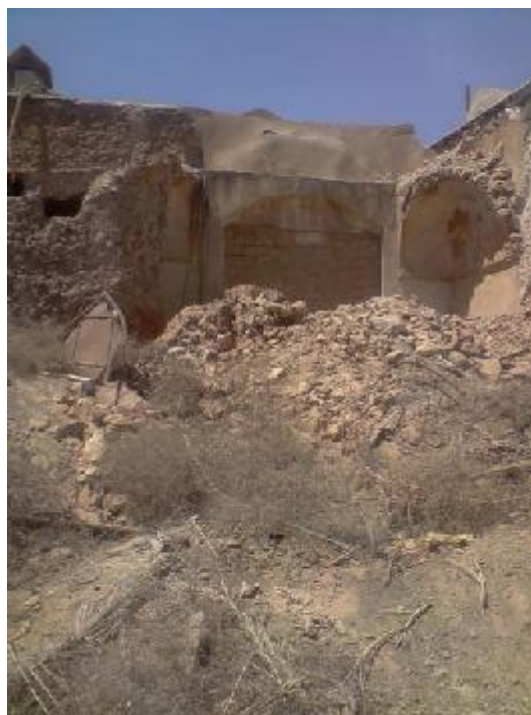
Above right, northern, rear, elevation of the Saray gateway, showing the collapsed vaults.

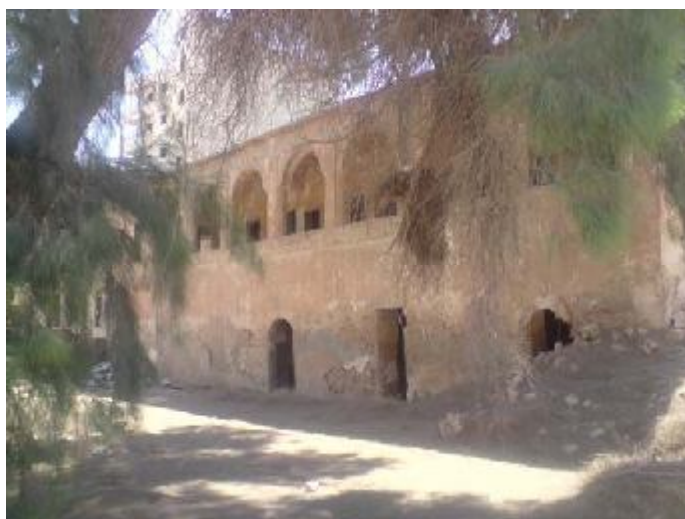
The surviving barracks building (*right*) is a two-storey structure, with vaulted storey at ground-floor level, with a central row of columns supporting the vaults, and an upper storey with rooms accessed from a colonnaded corridor.

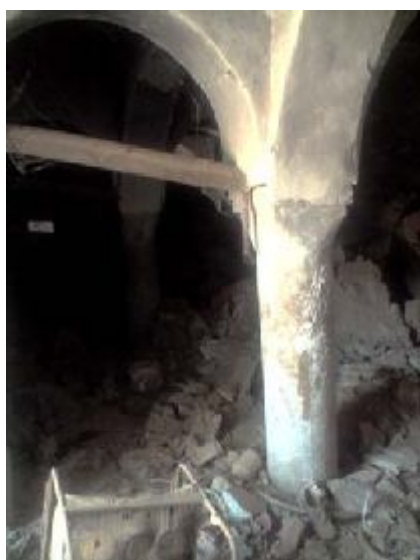
There is considerable differential settlement between the central row of columns and the exterior walls, less so where the ground floor has been divided by partition walls on the line of the columns, which has helped support the vaults. Where the columns are free-standing, however, the settlement is very marked and parts of the vaults have collapsed (*left*). The structure must be checked by a structural engineer qualified in evaluating historic buildings.

Left, the timber tie between the outer wall and the central column was originally horizontal, showing the extent of subsidence of the central row of columns.

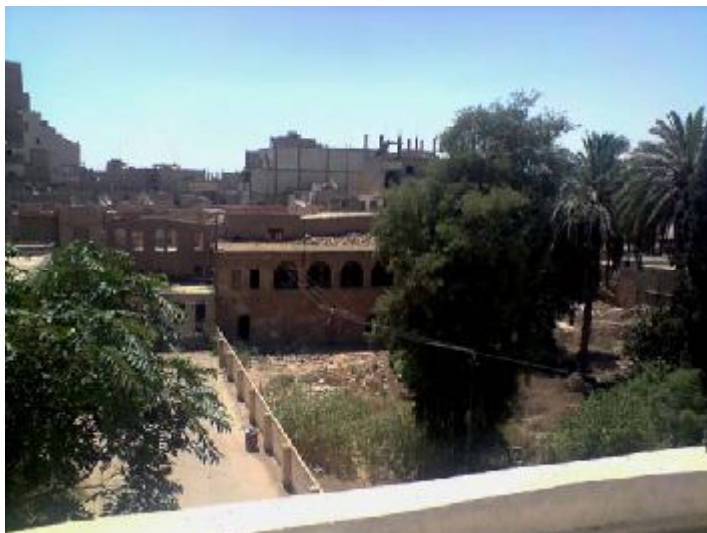
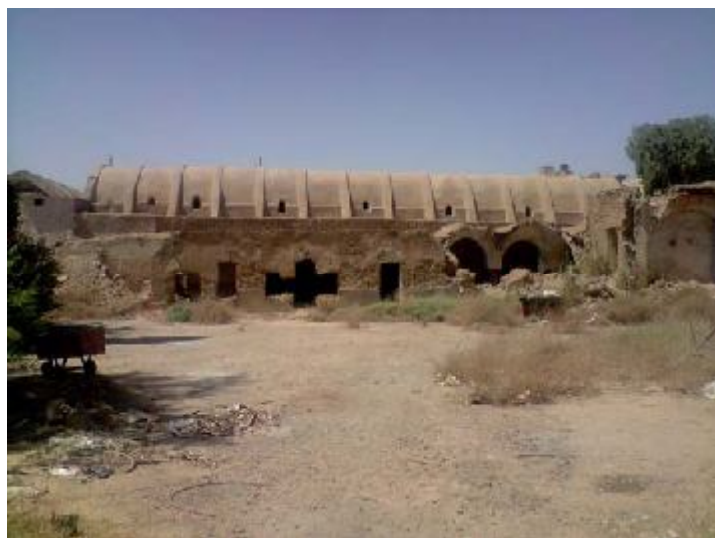
The other sides of the courtyard contained a kitchen and stables, which survive in a state of

dereliction or collapse. All these buildings are capable of restoration, but the courtyard also has considerable potential for performing a range of new functions linked to the proposed multi-purpose cultural centre and can serve as a link between the main cultural centre in the Saray building and the souk itself.

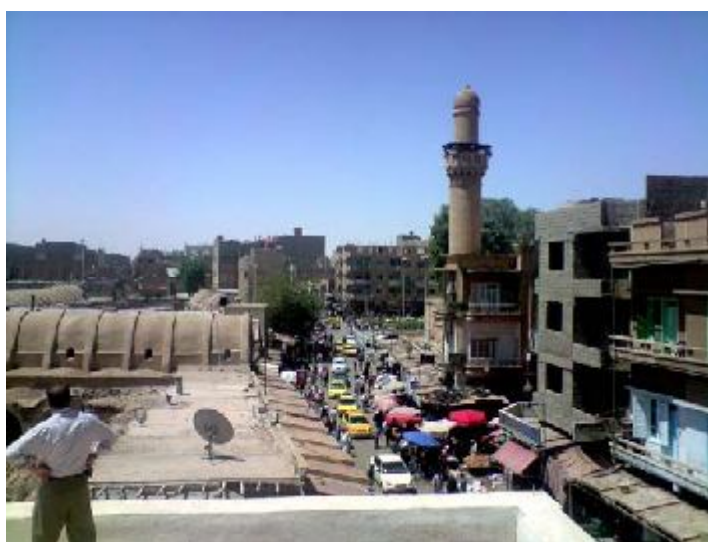
The project area is restricted to the souk complex, the Saray building and the barracks courtyard. This will result in the rehabilitation of the eastern side of Al-Saraya Street, while the opposite, western, side will remain untouched.

Above, Al-Saraya Street should be treated as a unity.

The experience of UNESCO in other heritage cities demonstrates that both sides of a street should be conserved under the same management regime.

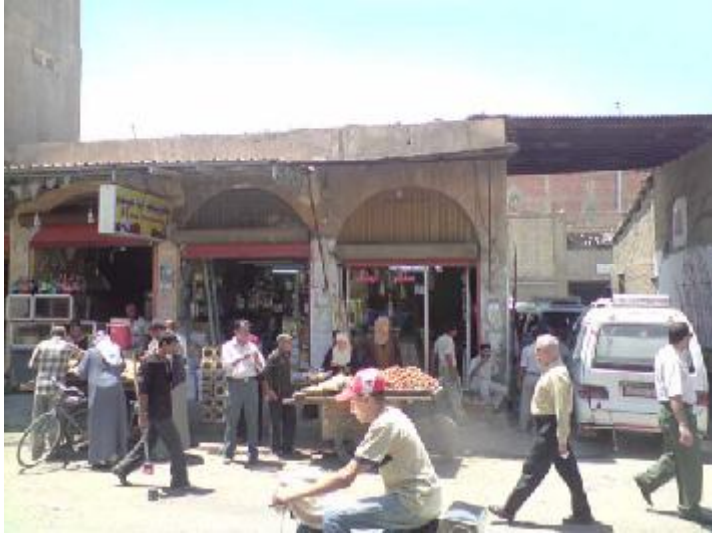
In any case, many of the shops immediately outside the souk complex have their own architectural quality (*left*). If this suggestion is accepted, then the boundary should lie on the property boundary at the rear of the shops on the far side of the streets than define the souk complex on its southern and western sides.
